Intersection ID: N/A	Main Street: PERTH_MOOR_RD	Cross Street: HAMILTON_BRIDGE_RD	Location:	SE
ADA ID: C8C77D17B5D5	Ramp Type: Perp	Initial Pass/Fail: Fail	Overall Compliance: No	Severity Score: 26.25

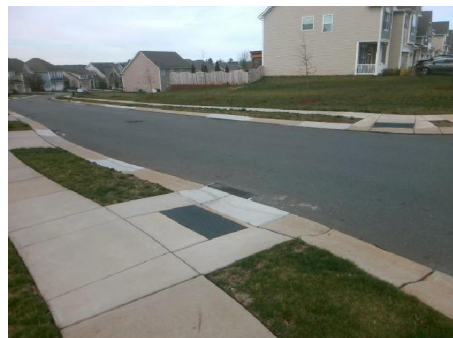
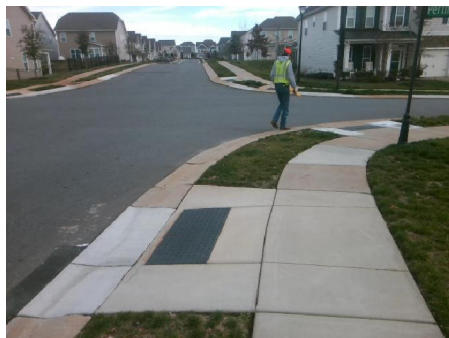
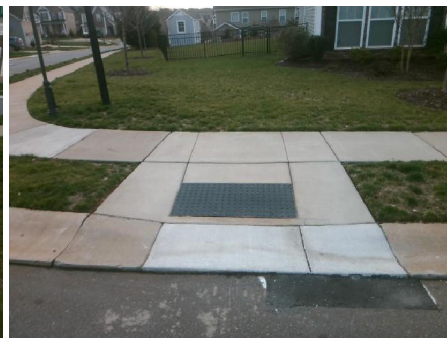
Not Found, R304.2.2

Compliance	Description	Data	Compliance	Description	Data
N/A	Ramp Length (in)	47.5	No	Ramp Slope (%)	12.4
Yes	Ramp Width (in)	48.0	Yes	Ramp XSlope (%)	2.2
N/A	Flare Type LT	N/A	N/A	Flare Type RT	N/A
N/A	Flare Slope LT (%)	N/A	N/A	Flare Slope RT (%)	N/A
N/A	Flare Traversable LT?	N/A	N/A	Flare Traversable RT?	N/A
N/A	Landing Length (in)	N/A	N/A	DWS Provided?	N/A
N/A	Landing Width (in)	N/A	N/A	DWS Contrast?	N/A
N/A	Landing Slope (%)	N/A	N/A	DWS Length (in)	N/A
N/A	Landing X Slope (%)	N/A	N/A	DWS Full Width?	N/A
N/A	Landing Curb? (Y/N)	N/A	N/A	DWS Offset (in)	N/A
N/A	Shared Landing?	N/A			
N/A	Gutter Ponding?	N/A	N/A	Gutter Slope (%)	N/A
N/A	Gutter Lip Ht (in)	1.0	N/A	Gutter X Slope (%)	N/A
N/A	Painted X Walk1?	No	N/A	Painted X Walk2?	N/A
	X Walk 1 Direction	To NW		X Walk 2 Direction	N/A
N/A	X Walk 1 Width (in)	N/A	N/A	X Walk 2 Width (in)	N/A
	X Walk 1 Slope (%)	2.3		X Walk 2 Slope (%)	N/A
	X Walk 1 X Slope (%)	4.2		X Walk 2 X Slope (%)	N/A

N/A	Ramp inside XWalk1?	N/A	N/A	Ramp inside XWalk2?	N/A
	Road Slope (%)	N/A	N/A	Clear Space?	N/A
	Road X Slope (%)	N/A	N/A	Clear Space to XWalk (in)	N/A
N/A	Any Obstructions?	N/A	N/A	Storm Grate/Utility Hazard?	N/A
	Obstruction Type			Storm Grate/Utility Type	
		N/A			N/A
			Yes	Surface Condition? (G/P)	Good

Remove & Replace Entire Ramp.
