# Access Compliance Report

## Public Rights-of-Way

Intersection ID: 47910	Main Street: ROOK_RD	Cross Street: MOUNTAIN_QUAIL_DR	Location: S
ADA ID: C8C99DF1057B	Ramp Type: PerpDiag	Initial Pass/Fail: Fail	Overall Compliance: No
		Severity Score: 10

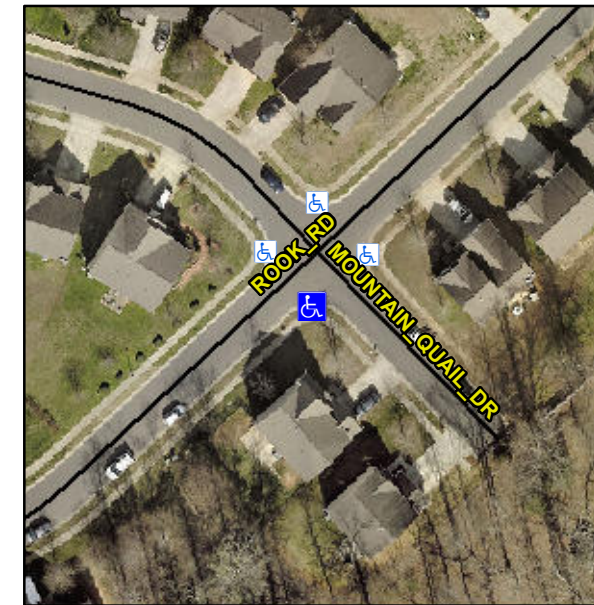
**Not Found, R304.5.1, R304.5.3**

Compliance	Description	Data	Compliance	Description	Data
N/A	Ramp Length (in)	51.0	Yes	Ramp Slope (%)	7.6
No	Ramp Width (in)	37.5	No	Ramp XSlope (%)	3.8
N/A	Flare Type LT	N/A	N/A	Flare Type RT	N/A
N/A	Flare Slope LT (%)	N/A	N/A	Flare Slope RT (%)	N/A
N/A	Flare Traversable LT?	N/A	N/A	Flare Traversable RT?	N/A
N/A	Landing Length (in)	N/A	N/A	DWS Provided?	N/A
N/A	Landing Width (in)	N/A	N/A	DWS Contrast?	N/A
N/A	Landing Slope (%)	N/A	N/A	DWS Length (in)	N/A
N/A	Landing X Slope (%)	N/A	N/A	DWS Full Width?	N/A
N/A	Landing Curb? (Y/N)	N/A	N/A	DWS Offset (in)	N/A
N/A	Shared Landing?	N/A			
N/A	Gutter Ponding?	N/A	N/A	Gutter Slope (%)	N/A
N/A	Gutter Lip Ht (in)	N/A	N/A	Gutter X Slope (%)	N/A
N/A	Painted X Walk1?	No	N/A	Painted X Walk2?	No
	X Walk 1 Direction	To SE		X Walk 2 Direction	To NW
N/A	X Walk 1 Width (in)	N/A	N/A	X Walk 2 Width (in)	N/A
	X Walk 1 Slope (%)	4.8		X Walk 2 Slope (%)	1.4
	X Walk 1 X Slope (%)	2.2		X Walk 2 X Slope (%)	5.3

N/A	Ramp inside XWalk1?	N/A	N/A	Ramp inside XWalk2?	N/A
	Road Slope (%)	3.4	N/A	Clear Space?	N/A
	Road X Slope (%)	5.2	N/A	Clear Space to XWalk (in)	N/A
N/A	Any Obstructions?	N/A	N/A	Storm Grate/Utility Hazard?	N/A
	Obstruction Type			Storm Grate/Utility Type	
		N/A			N/A
			Yes	Surface Condition? (G/P)	Good

**Remove & Replace Curb Ramp With Two New Directional Ramps or Equivalent.**
