Access Compliance Report

Public Rights-of-Way

(Curb Ramps)

Intersection ID: 43665	Main Street: HUNTINGTON_MEADOW_LN	Cross Street: STEELE_CREEK_RD	Location: SE
ADA ID: C8D12C537ECB	Ramp Type: PerpDiag	Initial Pass/Fail: Fail	Overall Compliance: No
Severity Score: 22.5			
Codes/Mitigation Info/Possible Solution		Field Measurements/Component Compliance

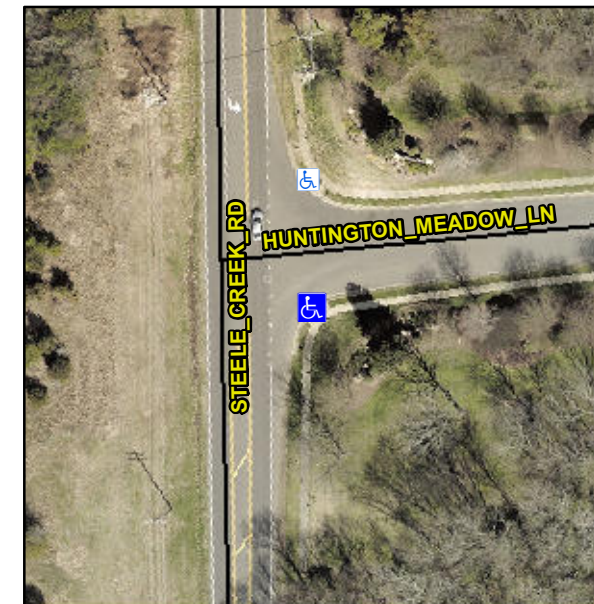
Compliance	Description	Data	Compliance	Description	Data
N/A	Ramp Length (in)	16.5	No	Ramp Slope (%)	10.4
No	Ramp Width (in)	41.0	No	Ramp XSlope (%)	4.9
N/A	Flare Type LT	N/A	N/A	Flare Type RT	N/A
N/A	Flare Slope LT (%)	N/A	N/A	Flare Slope RT (%)	N/A
N/A	Flare Traversable LT?	N/A	N/A	Flare Traversable RT?	N/A
N/A	Landing Length (in)	N/A	N/A	DWS Provided?	N/A
N/A	Landing Width (in)	N/A	N/A	DWS Contrast?	N/A
N/A	Landing Slope (%)	N/A	N/A	DWS Length (in)	N/A
N/A	Landing X Slope (%)	N/A	N/A	DWS Full Width?	N/A
N/A	Landing Curb? (Y/N)	N/A	N/A	DWS Offset (in)	N/A
N/A	Shared Landing?	N/A			
N/A	Gutter Ponding?	N/A	N/A	Gutter Slope (%)	N/A
N/A	Gutter Lip Ht (in)	N/A	N/A	Gutter X Slope (%)	N/A
N/A	Painted X Walk1?	No	N/A	Painted X Walk2?	No
	X Walk 1 Direction	To N		X Walk 2 Direction	To W
N/A	X Walk 1 Width (in)	N/A	N/A	X Walk 2 Width (in)	N/A
	X Walk 1 Slope (%)	2.0		X Walk 2 Slope (%)	3.8
	X Walk 1 X Slope (%)	2.2		X Walk 2 X Slope (%)	0.7

N/A	Ramp inside XWalk1?	N/A	N/A	Ramp inside XWalk2?	N/A
	Road Slope (%)	4.3	N/A	Clear Space?	N/A
	Road X Slope (%)	0.7	N/A	Clear Space to XWalk (in)	N/A
N/A	Any Obstructions?	N/A	N/A	Storm Grate/Utility Hazard?	N/A
	Obstruction Type			Storm Grate/Utility Type	
		N/A			N/A
			Yes	Surface Condition? (G/P)	Good

Possible Solutions:

Remove & Replace Curb Ramp With Two New Directional Ramps or Equivalent.
