# Access Compliance Report

## Public Rights-of-Way

Intersection ID: 12848	Main Street: S_MINT_ST	Cross Street: W_PALMER_ST	Location: S
ADA ID: C8E23CD0F1BF	Ramp Type: PerpDiag	Initial Pass/Fail: Fail	Overall Compliance: No
			Severity Score: 41.25

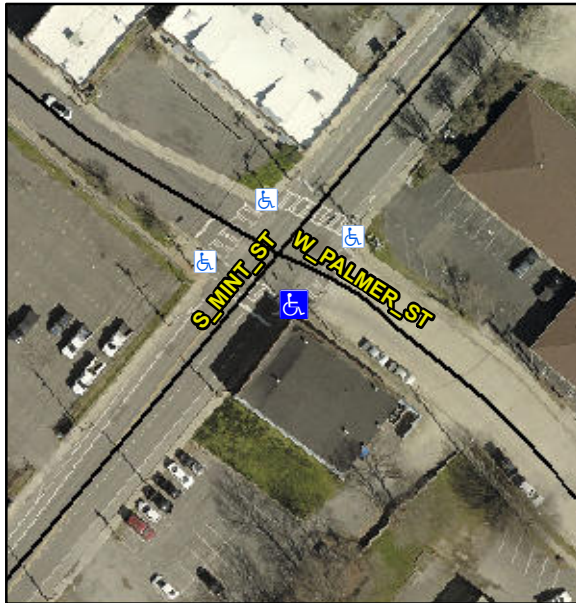
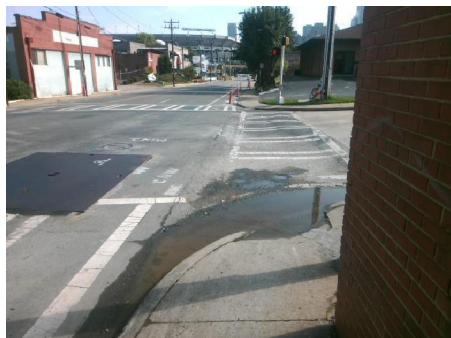
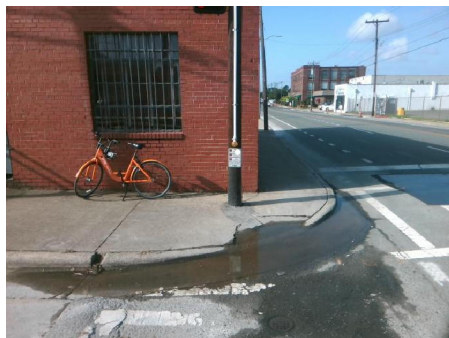
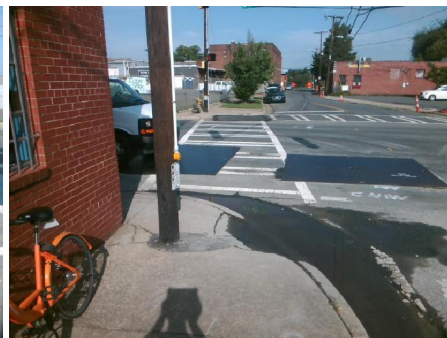
**R304.2.2, R304.5.3, R302.7**

Compliance	Description	Data	Compliance	Description	Data
N/A	Ramp Length (in)	42.0	No	Ramp Slope (%)	12.6
Yes	Ramp Width (in)	48.0	No	Ramp XSlope (%)	2.9
N/A	Flare Type LT	N/A	N/A	Flare Type RT	N/A
N/A	Flare Slope LT (%)	N/A	N/A	Flare Slope RT (%)	N/A
N/A	Flare Traversable LT?	N/A	N/A	Flare Traversable RT?	N/A
N/A	Landing Length (in)	N/A	N/A	DWS Provided?	N/A
N/A	Landing Width (in)	N/A	N/A	DWS Contrast?	N/A
N/A	Landing Slope (%)	N/A	N/A	DWS Length (in)	N/A
N/A	Landing X Slope (%)	N/A	N/A	DWS Full Width?	N/A
N/A	Landing Curb? (Y/N)	N/A	N/A	DWS Offset (in)	N/A
N/A	Shared Landing?	N/A			
N/A	Gutter Ponding?	N/A	N/A	Gutter Slope (%)	N/A
N/A	Gutter Lip Ht (in)	N/A	N/A	Gutter X Slope (%)	N/A
N/A	Painted X Walk1?	Yes	N/A	Painted X Walk2?	Yes
	X Walk 1 Direction	To NE		X Walk 2 Direction	To NW
N/A	X Walk 1 Width (in)	82.0	N/A	X Walk 2 Width (in)	113.0
	X Walk 1 Slope (%)	0.6		X Walk 2 Slope (%)	2.1
	X Walk 1 X Slope (%)	0.5		X Walk 2 X Slope (%)	0.4

N/A	Ramp inside XWalk1?	Yes	N/A	Ramp inside XWalk2?	Yes
	Road Slope (%)	1.2	N/A	Clear Space?	N/A
	Road X Slope (%)	0.3	N/A	Clear Space to XWalk (in)	N/A
N/A	Any Obstructions?	N/A	N/A	Storm Grate/Utility Hazard?	N/A
	Obstruction Type			Storm Grate/Utility Type	
		N/A			N/A
		No		Surface Condition? (G/P)	Poor

**Remove & Replace Curb Ramp With Two New Directional Ramps or Equivalent.**
