Access Compliance Report

Public Rights-of-Way

(Curb Ramps)

Intersection ID: 10020349	Main Street: BALLANTYNE_COMMONS_PY	Cross Street: N/A	Location: SW
ADA ID: C8E63EA96578	Ramp Type: Perp	Initial Pass/Fail: Fail	Overall Compliance: No
Severity Score: 17.5			
Codes/Mitigation Info/Possible Solution		Field Measurements/Component Compliance

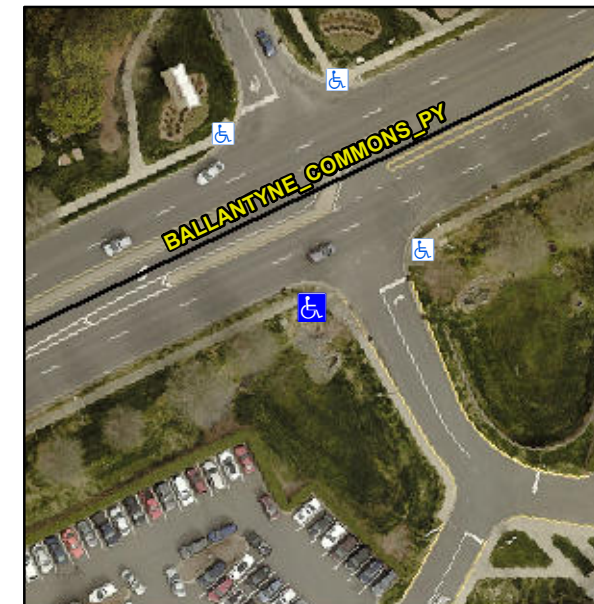
Not Found, R304.5.1

Compliance	Description	Data	Compliance	Description	Data
N/A	Ramp Length (in)	106.0	Yes	Ramp Slope (%)	6.2
No	Ramp Width (in)	32.5	Yes	Ramp XSlope (%)	0.9
N/A	Flare Type LT	N/A	N/A	Flare Type RT	N/A
N/A	Flare Slope LT (%)	N/A	N/A	Flare Slope RT (%)	N/A
N/A	Flare Traversable LT?	N/A	N/A	Flare Traversable RT?	N/A
N/A	Landing Length (in)	N/A	N/A	DWS Provided?	N/A
N/A	Landing Width (in)	N/A	N/A	DWS Contrast?	N/A
N/A	Landing Slope (%)	N/A	N/A	DWS Length (in)	N/A
N/A	Landing X Slope (%)	N/A	N/A	DWS Full Width?	N/A
N/A	Landing Curb? (Y/N)	N/A	N/A	DWS Offset (in)	N/A
N/A	Shared Landing?	N/A			
N/A	Gutter Ponding?	N/A	N/A	Gutter Slope (%)	N/A
N/A	Gutter Lip Ht (in)	N/A	N/A	Gutter X Slope (%)	N/A
N/A	Painted X Walk1?	No	N/A	Painted X Walk2?	N/A
	X Walk 1 Direction	To E		X Walk 2 Direction	N/A
N/A	X Walk 1 Width (in)	N/A	N/A	X Walk 2 Width (in)	N/A
	X Walk 1 Slope (%)	3.2		X Walk 2 Slope (%)	N/A
	X Walk 1 X Slope (%)	2.3		X Walk 2 X Slope (%)	N/A

N/A	Ramp inside XWalk1?	N/A	N/A	Ramp inside XWalk2?	N/A
	Road Slope (%)	N/A	N/A	Clear Space?	N/A
	Road X Slope (%)	N/A	N/A	Clear Space to XWalk (in)	N/A
N/A	Any Obstructions?	N/A	N/A	Storm Grate/Utility Hazard?	N/A
	Obstruction Type			Storm Grate/Utility Type	
		N/A			N/A
			Yes	Surface Condition? (G/P)	Good

Possible Solutions:

Remove & Replace Entire Ramp.

Total Cost: \$ 1850.00
