Access Compliance Report

Public Rights-of-Way

(Curb Ramps)

Intersection ID: 46492	Main Street: SHOPTON_RD_WEST	Cross Street: CASTLECOVE_RD	Location: E
ADA ID: C8F849C6736D	Ramp Type: PerpDiag	Initial Pass/Fail: Fail	Overall Compliance: No
Severity Score: 22.5			
Codes/Mitigation Info/Possible Solution		Field Measurements/Component Compliance

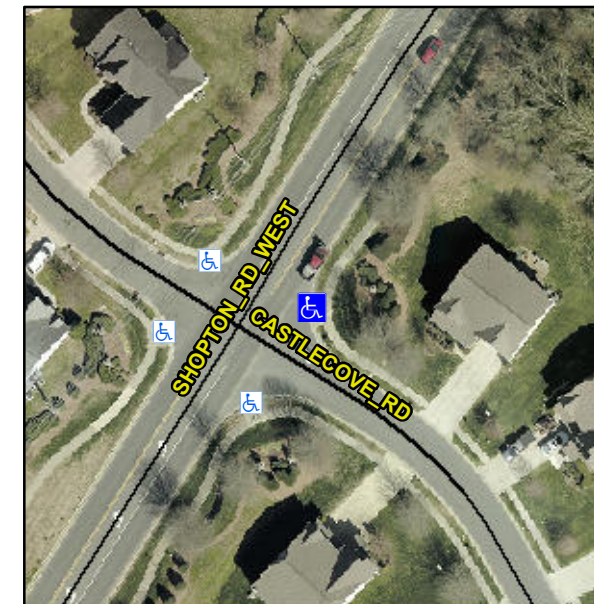
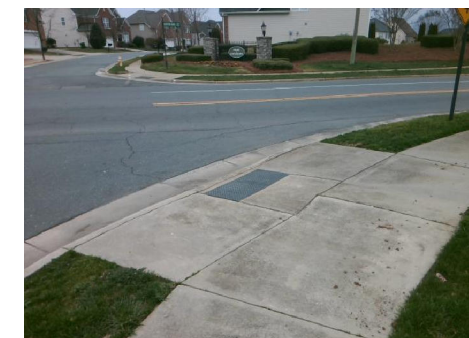
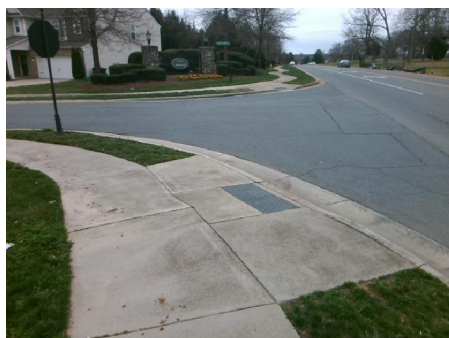
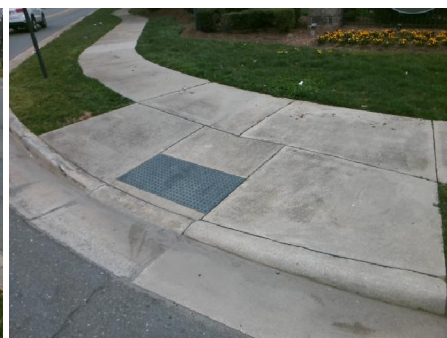
Not Found, R304.5.1, R304.2.2, R304.5.3

Compliance	Description	Data	Compliance	Description	Data
N/A	Ramp Length (in)	60.0	No	Ramp Slope (%)	8.4
No	Ramp Width (in)	47.0	No	Ramp XSlope (%)	2.8
N/A	Flare Type LT	N/A	N/A	Flare Type RT	N/A
N/A	Flare Slope LT (%)	N/A	N/A	Flare Slope RT (%)	N/A
N/A	Flare Traversable LT?	N/A	N/A	Flare Traversable RT?	N/A
N/A	Landing Length (in)	N/A	N/A	DWS Provided?	N/A
N/A	Landing Width (in)	N/A	N/A	DWS Contrast?	N/A
N/A	Landing Slope (%)	N/A	N/A	DWS Length (in)	N/A
N/A	Landing X Slope (%)	N/A	N/A	DWS Full Width?	N/A
N/A	Landing Curb? (Y/N)	N/A	N/A	DWS Offset (in)	N/A
N/A	Shared Landing?	N/A			
N/A	Gutter Ponding?	N/A	N/A	Gutter Slope (%)	N/A
N/A	Gutter Lip Ht (in)	N/A	N/A	Gutter X Slope (%)	N/A
N/A	Painted X Walk1?	No	N/A	Painted X Walk2?	No
	X Walk 1 Direction	To NW		X Walk 2 Direction	To SW
N/A	X Walk 1 Width (in)	N/A	N/A	X Walk 2 Width (in)	N/A
	X Walk 1 Slope (%)	3.8		X Walk 2 Slope (%)	1.8
	X Walk 1 X Slope (%)	0.3		X Walk 2 X Slope (%)	2.0

N/A	Ramp inside XWalk1?	N/A	N/A	Ramp inside XWalk2?	N/A
	Road Slope (%)	1.6	N/A	Clear Space?	N/A
	Road X Slope (%)	4.5	N/A	Clear Space to XWalk (in)	N/A
N/A	Any Obstructions?	N/A	N/A	Storm Grate/Utility Hazard?	N/A
	Obstruction Type			Storm Grate/Utility Type	
		N/A			N/A
			Yes	Surface Condition? (G/P)	Good

Remove & Replace Curb Ramp With Two New Directional Ramps or Equivalent.
