# Access Compliance Report

## Public Rights-of-Way

### (Curb Ramps)

| Intersection ID: 29250 | Main Street: LONGACRE_DR | Cross Street: VINE_CLIFF_LN | Location: SE |

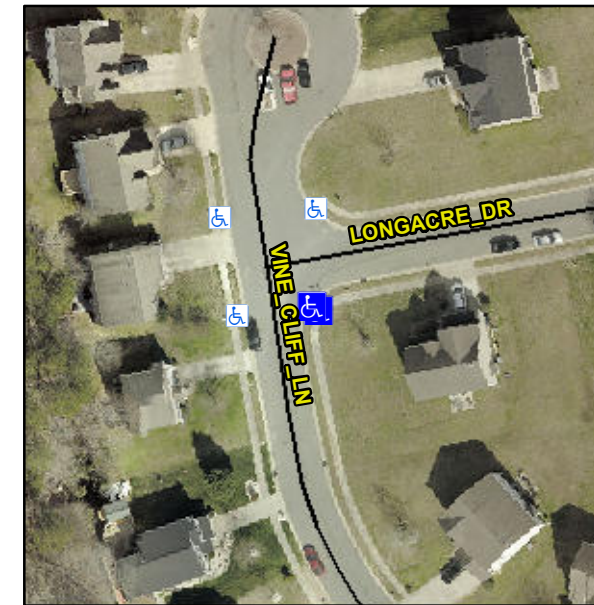
| ADA ID: C8FCF9D2B1DB | Ramp Type: PerpDiag | Initial Pass/Fail: Fail | Overall Compliance: No |
| | | Severity Score: 22.5 | |

**Not Found, R304.5.1, R304.2.2, R304.5.3**

| Compliance | Description | Data | Compliance | Description | Data |
|---|---|---|---|---|---|
| N/A | Ramp Length (in) | 47.0 | No | Ramp Slope (%) | 8.4 |
| No | Ramp Width (in) | 47.0 | No | Ramp XSlope (%) | 2.9 |

**Remove & Replace Curb Ramp With Two New Directional Ramps or Equivalent.**

Total Cost: \$ 3200.00
