Access Compliance Report Public Rights-of-Way (Curb Ramps)

Intersection ID: 7004 Main Street: CEDARHURST DR Cross Street: KENMONT_DR Location: NW ADA ID: C8FFE46D43B2 Ramp Type: BlendTrans1 Initial Pass/Fail: Fail **Overall Compliance: No** Severity Score: 21.25

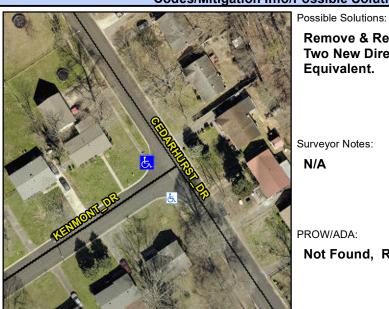
Field Measurements/Component Compliance						
Compliance Description Data		Compliance Description		Data		
N/A	Ramp Length (in)	111.0	Yes	BlendTrans Slope (%)	1.7	
No	Ramp Width (in)	39.0	No	BlendTrans XSlope (%)	5.4	
N/A	Flare Type LT	N/A	N/A	Flare Type RT	N/A	
N/A	Flare Slope LT (%)	N/A	N/A	Flare Slope RT (%)	N/A	
N/A	Flare Traversable LT?	N/A	N/A	Flare Traversable RT?	N/A	
N/A	Landing Length (in)	N/A	N/A	DWS Provided?	N/A	
N/A	Landing Width (in)	N/A	N/A	DWS Contrast?	N/A	
N/A	Landing Slope (%)	N/A	N/A	DWS Length (in)	N/A	
N/A	Landing X Slope (%)	N/A	N/A	DWS Full Width?	N/A	
N/A	Landing Curb? (Y/N)	N/A	N/A	DWS Offset (in)	N/A	
N/A	Shared Landing?	N/A				
N/A	Gutter Ponding?	N/A	N/A	Gutter Slope (%)	N/A	
N/A	Gutter Lip Ht (in)	N/A	N/A	Gutter X Slope (%)	N/A	
N/A	Painted X Walk1?	No	N/A	Painted X Walk2?	N/A	
	X Walk 1 Direction	To SE		X Walk 2 Direction	N/A	
	X Walk 1 Width (in)	N/A		X Walk 2 Width (in)	N/A

X Walk 1 Slope (%)	6.3		X Walk 2 Slope (%)	N/A	
	X Walk 1 X Slope (%)	2.2		X Walk 2 X Slope (%)	N/A	
N/A	Ramp inside XWalk1?	N/A	N/A	Ramp inside XWalk2?	N/A	
	Road Slope (%)	2.2		Clear Space?	N/A	
	Road X Slope (%)	6.3	N/A	Clear Space to XWalk (in)	N/A	
N/A	Any Obstructions?	N/A	N/A	Storm Grate/Utility Hazard?	N/A	
	Obstruction Type		l	Storm Grate/Utility Type		
		N/A	l		N/A	
			Yes	Surface Condition? (G/P)	Good	
	2794		No	Curb Slope (%)	9.3

Remove & Replace Curb Ramp With Two New Directional Ramps or Equivalent.

Found, R304.5.1, R304.5.3
