Access Compliance Report Public Rights-of-Way (Curb Ramps)

Intersection ID: 49137 Main Street: LESTER HILL CT **Cross Street: POPE FARM RD** Location: NW ADA ID: C905DD972FDD Ramp Type: PerpDiag Initial Pass/Fail: Pass **Overall Compliance: No Severity Score:** 5.25

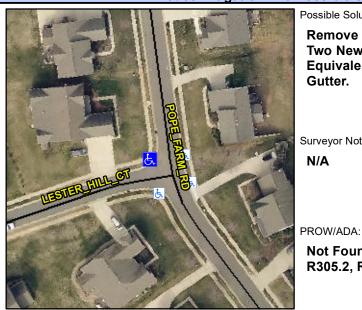
Compliance Description Page Compliance Description Details of the Compliance Description Description Details of the Compliance Description Descrip					
Compliance Description		Data		Diance Description	Data
N/A	Ramp Length (in)	48.0	Yes	Ramp Slope (%)	7.0
Yes	Ramp Width (in)	48.0	No	Ramp XSlope (%)	2.2
N/A	Flare Type LT	Sloped	N/A	Flare Type RT	N/A
N/A	Flare Slope LT (%)	8.5	Yes	Flare Slope RT (%)	2.6
N/A	Flare Traversable LT?	Yes	N/A	Flare Traversable RT?	Yes
No	Landing Length (in)	47.0	Yes	DWS Provided?	Yes
Yes	Landing Width (in)	48.0	Yes	DWS Contrast?	Yes
Yes	Landing Slope (%)	1.5	Yes	DWS Length (in)	24.5
No	Landing X Slope (%)	2.5	Yes	DWS Full Width?	Yes
N/A	Landing Curb? (Y/N)	No	No	DWS Offset (in)	8.0
N/A	Shared Landing?	No			
Yes	Gutter Ponding?	No	No	Gutter Slope (%)	6.3
Yes	Gutter Lip Ht (in)	0.0	Yes	Gutter X Slope (%)	1.7
N/A	Painted X Walk1?	No	N/A	Painted X Walk2?	No
	X Walk 1 Direction	To S		X Walk 2 Direction	To E

N/A	X Walk 1 Width (in)	N/A	N/A	X Walk 2 Width (in)	N/A
	X Walk 1 Slope (%)	1.6		X Walk 2 Slope (%)	0.9
	X Walk 1 X Slope (%)	1.8		X Walk 2 X Slope (%)	0.0
N/A	Ramp inside XWalk1?	N/A	N/A	Ramp inside XWalk2?	N/A
	Road Slope (%)	1.4	N/A	Clear Space?	Yes
	Road X Slope (%)	2.4	N/A	Clear Space to XWalk (in)	N/A
Yes	Any Obstructions?	No	Yes	Storm Grate/Utility Hazard?	No
	Obstruction Type			Storm Grate/Utility Type	
		N/A			N/A
			Yes	Surface Condition? (G/P)	Good
.30		'	•	()

Possible Solutions: Remove & Replace Curb Ramp With Two New Directional Ramps or **Equivalent. Remove & Replace** Gutter. Surveyor Notes:

Not Found, R304.5.3, R304.2.1, R305.2, R304.5.4
