# Access Compliance Report

## Public Rights-of-Way

| Intersection ID: 30452 | Main Street: CRESCENT_EXECUTIVE_DR | Cross Street: GREEN_RIDGE_DR | Location: S |
| ADA ID: C910D7C7B79F | Ramp Type: Perp | Initial Pass/Fail: Fail | Overall Compliance: No |

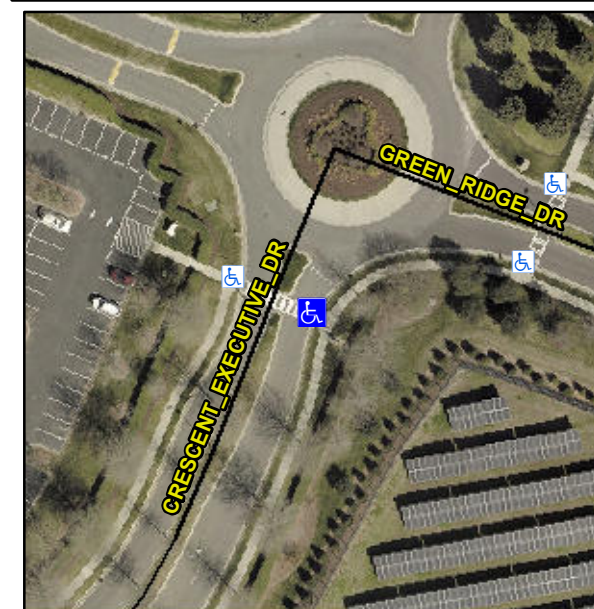
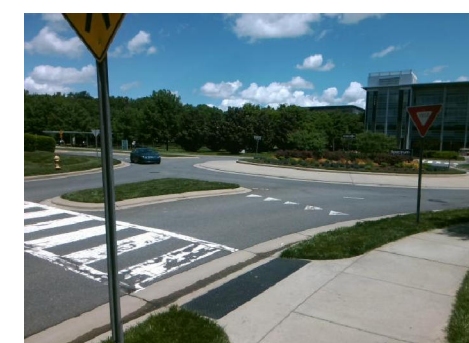
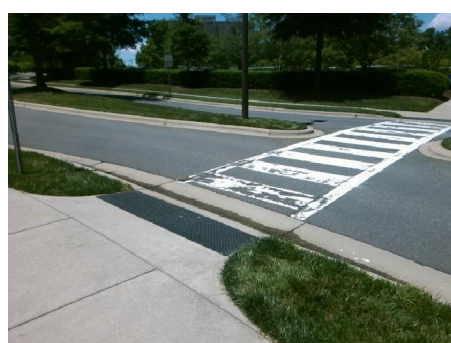
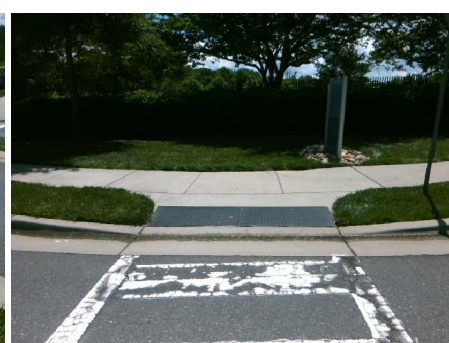
**Not Found, R304.2.2, R304.5.3**

| Compliance | Description | Data | Compliance | Description | Data |
|---|---|---|---|---|---|
| N/A | Ramp Length (in) | 48.0 | No | Ramp Slope (%) | 8.4 |
| Yes | Ramp Width (in) | 96.0 | No | Ramp XSlope (%) | 3.9 |

**Remove & Replace Entire Ramp.  
Restripe Crosswalk.**
