Access Compliance Report

Public Rights-of-Way

(Curb Ramps)

| Intersection ID: 4697 | Main Street: BELLA_VISTA_CT | Cross Street: REAMES_RD | Location: NW |

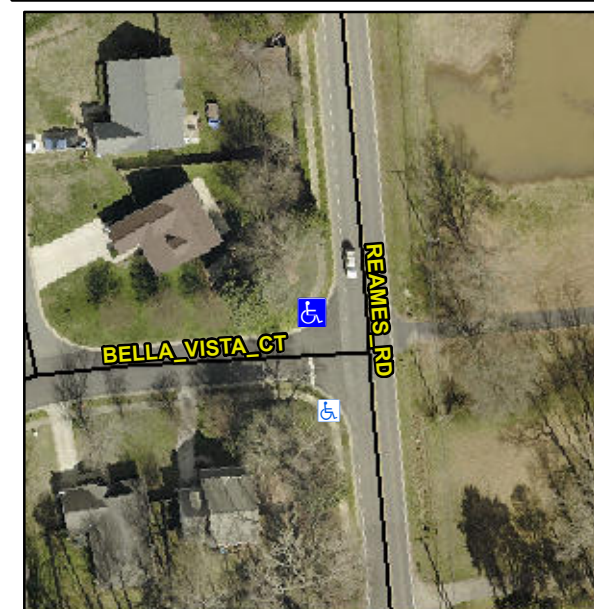
| ADA ID: C9123B9EA916 | Ramp Type: Perp | Initial Pass/Fail: Fail | Overall Compliance: No |
| Severity Score: 18.75 | | | |

Not Found, R304.5.1, R304.5.3

| Compliance | Description | Data | Compliance | Description | Data |
|---|---|---|---|---|---|
| N/A | Ramp Length (in) | 24.0 | Yes | Ramp Slope (%) | 7.2 |
| No | Ramp Width (in) | 33.0 | No | Ramp XSlope (%) | 2.8 |

Possible Solutions:

Remove & Replace Entire Ramp.

Total Cost: \$ 1850.00
