## Access Compliance Report Public Rights-of-Way (Curb Ramps)

ADA ID: C913091D91B4 Ramp Type: PerpDiag Initial Pass/Fail: Fail Overall Compliance: No Severity Score: 13.75

E W T HARRIS BV Signal N SHARON AMITY RD Signal Possible Solutions:

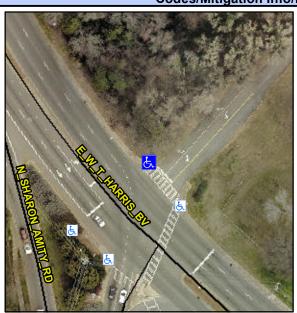
Not Found, R304.2.2, R304.5.3

| Field Measurements/Component Compilance | | | | | |
|---|---|---|---|---|---|
| N/A | Ramp Length (in) | 59.5 | No | Ramp Slope (%) | 8.6 |
| Yes | Ramp Width (in) | 48.0 | No | Ramp XSlope (%) | 2.1 |

Remove & Replace Curb Ramp With Two New Directional Ramps or Equivalent.
