# Access Compliance Report

## Public Rights-of-Way

### (Curb Ramps)

Intersection ID: 9996	Main Street: BARRINGTON_DR	Cross Street: WOODY_GLEN_PL	Location: NW
ADA ID: C920E8AB52C0	Ramp Type: Directional1	Initial Pass/Fail: Fail	Overall Compliance: No
		Severity Score: 25

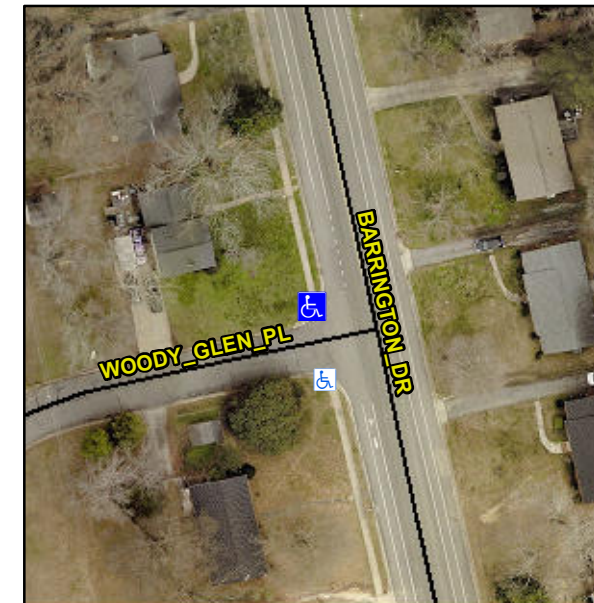
**R304.2.2**

Compliance	Description	Data	Compliance	Description	Data
N/A	Ramp Length (in)	66.5	N/A	Grade Break?	N/A
Yes	Ramp Width (in)	48.0	N/A	Grade Break Slope (%)	0.0
No	Ramp Slope (%)	13.5	N/A	Grade Break XSlope (%)	0.0
Yes	Ramp XSlope (%)	0.4			
N/A	Flare Type LT	N/A	N/A	Flare Type RT	N/A
N/A	Flare Slope LT (%)	N/A	N/A	Flare Slope RT (%)	0.0
N/A	Flare Traversable LT?	N/A	N/A	Flare Traversable RT?	N/A
N/A	Landing Length (in)	0.0	N/A	DWS Provided?	N/A
N/A	Landing Width (in)	0.0	N/A	DWS Contrast?	N/A
N/A	Landing Slope (%)	0.0	N/A	DWS Length (in)	N/A
N/A	Landing X Slope (%)	0.0	N/A	DWS Full Width?	N/A
N/A	Landing Curb? (Y/N)	N/A	N/A	DWS Offset LT (in)	N/A
N/A	Shared Landing?	N/A	N/A	DWS Offset RT (in)	N/A
N/A	Gutter Ponding?	0.0	N/A	Gutter Slope (%)	N/A
N/A	Gutter Lip Ht (in)	0.0	N/A	Gutter X Slope (%)	N/A
N/A	Painted X Walk1?	No		Road Slope (%)	3.5
	X Walk 1 Direction	To SE		Road X Slope (%)	3.1
	X Walk 1 Width (in)	N/A		Clear Space?	N/A

X Walk 1 Slope (%)	3.5	N/A	Clear Space to XWalk (in)	N/A
	X Walk 1 X Slope (%)	3.1	N/A	Storm Grate/Utility Hazard?	N/A
N/A	Ramp inside XWalk1?	N/A		Storm Grate/Utility Type	
N/A	Any Obstructions?	N/A			N/A
	Obstruction Type		Yes	Surface Condition? (G/P)	Good
			N/A	Curb Slope (%)	15.3

**Remove & Replace Entire Ramp.**

Total Cost: \$ 1600.00
