Access Compliance Report

Public Rights-of-Way

(Curb Ramps)

Intersection ID: 45154	Main Street: REID_OAKS_DR	Cross Street: MAGNASCO_LN	Location: SE
ADA ID: C92B5E2D468C	Ramp Type: PerpDiag	Initial Pass/Fail: Fail	Overall Compliance: No
			Severity Score: 18.75

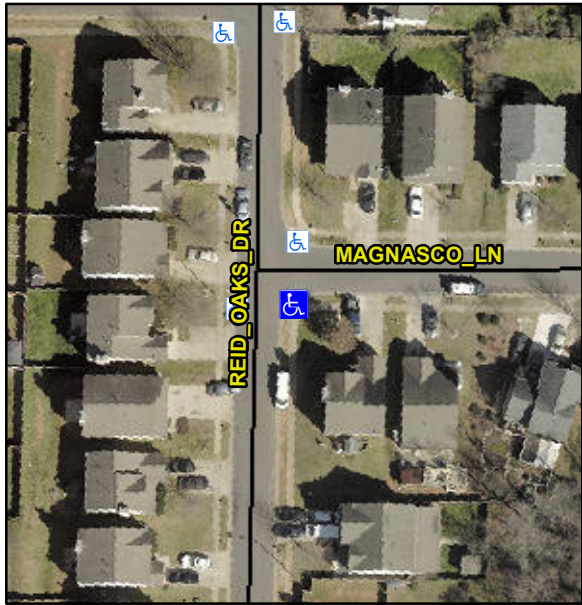
</div> <div>Street 1 NameMAGNASCO LNMagnasco Ln</div> <div>Stop Condition-Street 2StopSign</div> <div>Street 2 NameREID OAKS DRReid Oaks Dr</div> <div>Stop Condition-Street 1None</div> <div>Possible Solutions: Remove & Replace Curb Ramp With Two New Directional Ramps or Equivalent.</div> <div>Surveyor Notes: N/A</div> <div>PROW/ADA: R304.5.1, R304.5.3</div> <div>Total Cost:\$ 3200.00</div>			Compliance	Description	Data	Compliance	Description	Data
			N/A	Ramp Length (in)	47.5	Yes	Ramp Slope (%)	7.7
			No	Ramp Width (in)	35.5	No	Ramp XSlope (%)	3.4
			N/A	Flare Type LT	N/A	N/A	Flare Type RT	N/A
			N/A	Flare Slope LT (%)	N/A	N/A	Flare Slope RT (%)	N/A
			N/A	Flare Traversable LT?	N/A	N/A	Flare Traversable RT?	N/A
			N/A	Landing Length (in)	N/A	N/A	DWS Provided?	N/A
			N/A	Landing Width (in)	N/A	N/A	DWS Contrast?	N/A
