# Access Compliance Report

## Public Rights-of-Way

### (Curb Ramps)

Intersection ID: 27554	Main Street: BALLANTYNE MEADOWS DR	Cross Street: DEER RIDGE LN	Location: NW
ADA ID: C930BAF41AB6	Ramp Type: PerpDiag	Initial Pass/Fail: Fail	Overall Compliance: No
Severity Score: 12.5			
Codes/Mitigation Info/Possible Solution		Field Measurements/Component Compliance

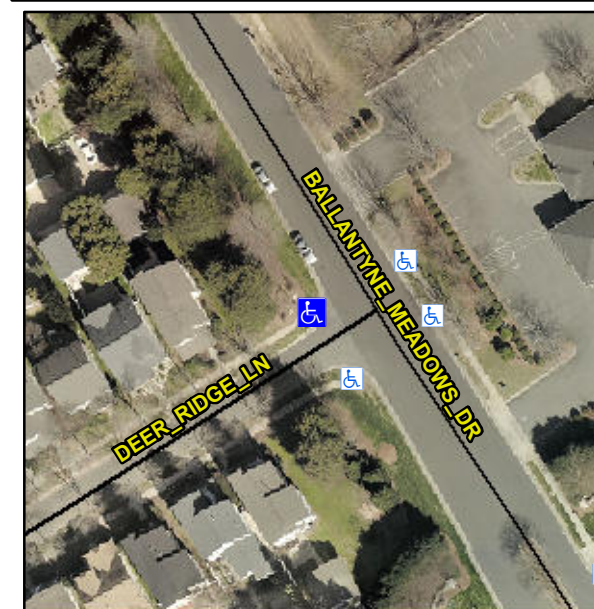
Compliance	Description	Data	Compliance	Description	Data
N/A	Ramp Length (in)	58.0	No	Ramp Slope (%)	11.5
Yes	Ramp Width (in)	48.0	Yes	Ramp XSlope (%)	0.7
N/A	Flare Type LT	N/A	N/A	Flare Type RT	N/A
N/A	Flare Slope LT (%)	N/A	N/A	Flare Slope RT (%)	N/A
N/A	Flare Traversable LT?	N/A	N/A	Flare Traversable RT?	N/A
N/A	Landing Length (in)	N/A	N/A	DWS Provided?	N/A
N/A	Landing Width (in)	N/A	N/A	DWS Contrast?	N/A
N/A	Landing Slope (%)	N/A	N/A	DWS Length (in)	N/A
N/A	Landing X Slope (%)	N/A	N/A	DWS Full Width?	N/A
N/A	Landing Curb? (Y/N)	N/A	N/A	DWS Offset (in)	N/A
N/A	Shared Landing?	N/A			
N/A	Gutter Ponding?	N/A	N/A	Gutter Slope (%)	N/A
N/A	Gutter Lip Ht (in)	N/A	N/A	Gutter X Slope (%)	N/A
N/A	Painted X Walk1?	No	N/A	Painted X Walk2?	No
	X Walk 1 Direction	To S		X Walk 2 Direction	To NW
N/A	X Walk 1 Width (in)	N/A	N/A	X Walk 2 Width (in)	N/A
	X Walk 1 Slope (%)	6.2		X Walk 2 Slope (%)	4.1
	X Walk 1 X Slope (%)	2.5		X Walk 2 X Slope (%)	5.8

N/A	Ramp inside XWalk1?	N/A	N/A	Ramp inside XWalk2?	N/A
	Road Slope (%)	0.6	N/A	Clear Space?	N/A
	Road X Slope (%)	9.8	N/A	Clear Space to XWalk (in)	N/A
N/A	Any Obstructions?	N/A	N/A	Storm Grate/Utility Hazard?	N/A
	Obstruction Type			Storm Grate/Utility Type	
		N/A			N/A
		Yes		Surface Condition? (G/P)	Good

**Remove & Replace Curb Ramp With Two New Directional Ramps or Equivalent.**

**R304.2.2**
