Access Compliance Report

Public Rights-of-Way

(Curb Ramps)

| Intersection ID: 15293 | | Main Street: ARDSLEY_RD | | Cross Street: QUEENS_RD | | Location: SW | | | | | | | | | | | |

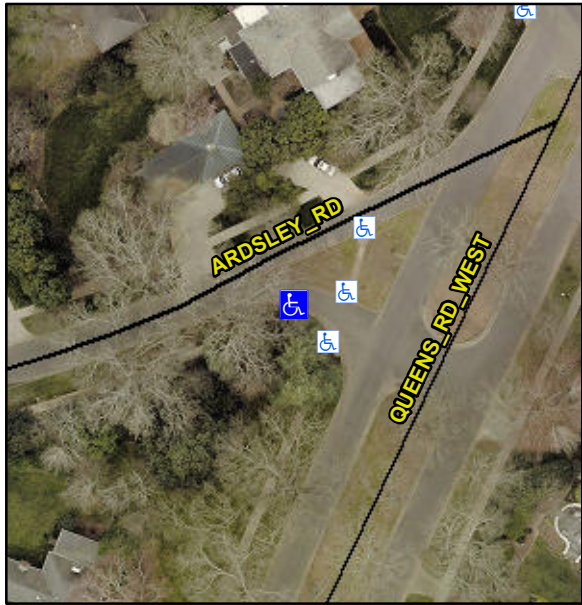
| <div></div> <div>Possible Solutions:</div> <div>Remove & Replace Entire Ramp.</div> <div>Surveyor Notes:</div> <div>N/A</div> <div>PROW/ADA:</div> <div>R304.5.3</div> <div>Street 1 Name</div> <div>ARDSLEY RD</div> <div>Stop Condition-Street 1</div> <div>StopSign</div> <div>Street 2 Name</div> <div>N/A</div> <div>Stop Condition-Street 2</div> <div>N/A</div> <div>Total Cost:</div> <div>\$</div> <div>1600.00</div> | | | | Compliance | | Description | | Data | | Compliance | | Description | | Data | | | |
| | | | | No | | Ramp XSlope (%) | | 5.3 | | | | | | | | | |

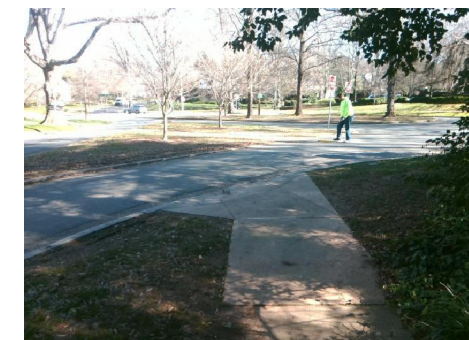
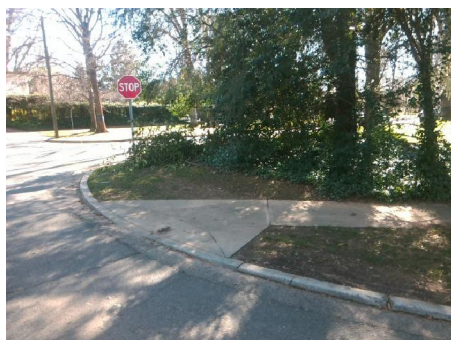
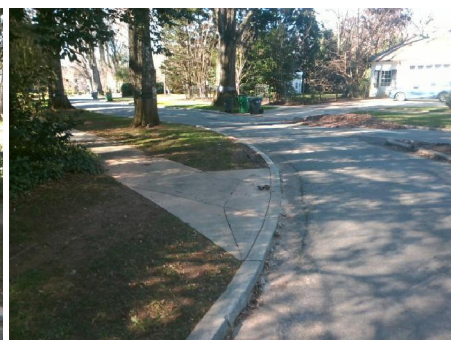
| ADA ID: C9340D4C6C42 | | Ramp Type: Directional1 | | Initial Pass/Fail: Fail | | Overall Compliance: No | | Severity Score: 12.5 | | | | | | | | | |
