# Access Compliance Report

## Public Rights-of-Way

| Intersection ID: 9100 | Main Street: BOYD_ST | Cross Street: NORWOOD_DR | Location: | N |
| ADA ID: C9588F064215 | Ramp Type: Perp | Initial Pass/Fail: Fail | Overall Compliance: No | Severity Score: 47.5 |

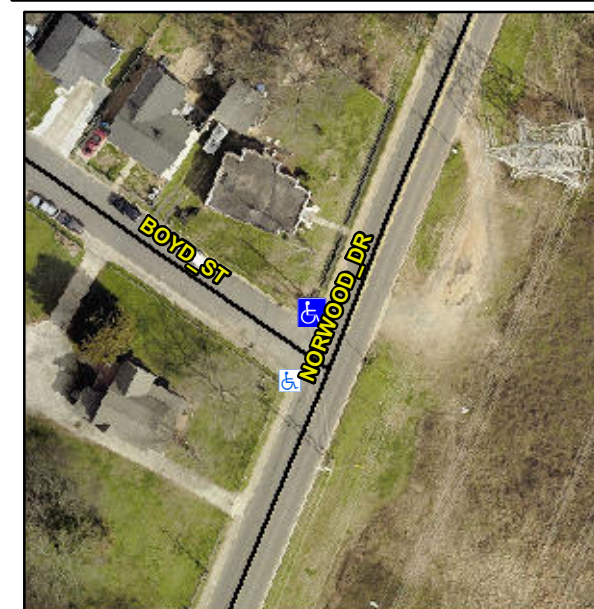
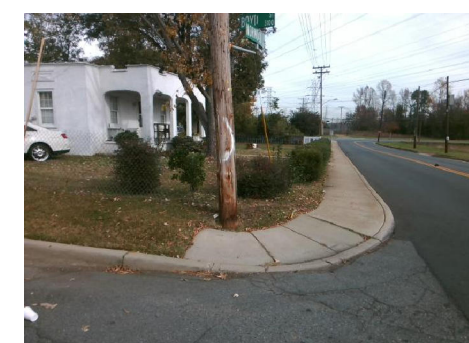
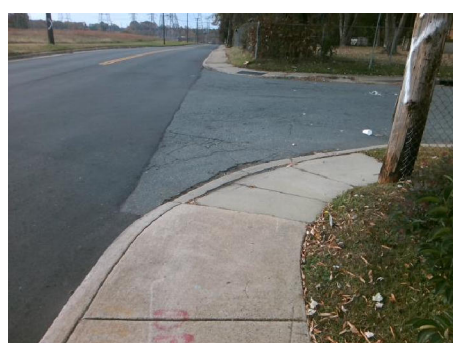
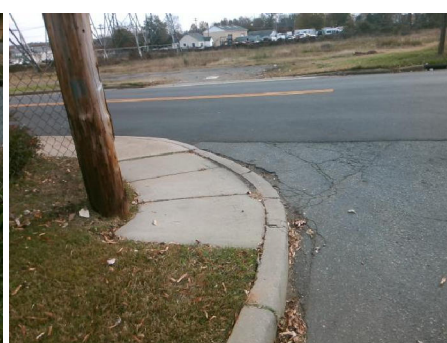
**Not Found, R304.5.1, R304.2.2**

| Compliance | Description | Data | Compliance | Description | Data |
|---|---|---|---|---|---|
| N/A | Ramp Length (in) | 48.0 | No | Ramp Slope (%) | 9.1 |
| No | Ramp Width (in) | 24.0 | Yes | Ramp XSlope (%) | 1.0 |

**Remove & Replace Entire Ramp.**

Total Cost: \$ 1850.00
