Access Compliance Report Public Rights-of-Way (Curb Ramps)

Intersection ID: 4656Main Street: OLD_STATESVILLE_RDCross Street: RATCLIFF_LNLocation: NWADA ID: C958A89A12DARamp Type: PerpInitial Pass/Fail: FailOverall Compliance: NoSeverity Score: 22.5

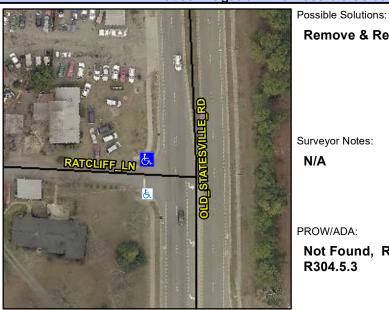
Field Measurements/Component Compliance							
Compl	iance Description	Data	Compl	liance	Description	Data	
N/A	Ramp Length (in)	60.0	No	Ramp	Slope (%)	10.1	
No	Ramp Width (in)	36.0	No	Ramp	XSlope (%)	2.9	
N/A	Flare Type LT	N/A	N/A	Flare	Type RT	N/A	
N/A	Flare Slope LT (%)	N/A	N/A	Flare	Slope RT (%)	N/A	
N/A	Flare Traversable LT?	N/A	N/A	Flare	Traversable RT?	N/A	
N/A	Landing Length (in)	N/A	N/A	DWS	Provided?	N/A	
N/A	Landing Width (in)	N/A	N/A	DWS	Contrast?	N/A	
N/A	Landing Slope (%)	N/A	N/A	DWS	Length (in)	N/A	
N/A	Landing X Slope (%)	N/A	N/A	DWS	Full Width?	N/A	
N/A	Landing Curb? (Y/N)	N/A	N/A	DWS	Offset (in)	N/A	
N/A	Shared Landing?	N/A					
N/A	Gutter Ponding?	N/A	N/A	Gutte	r Slope (%)	N/A	
N/A	Gutter Lip Ht (in)	N/A	N/A	Gutte	r X Slope (%)	N/A	
N/A	Painted X Walk1?	No	N/A	Painte	ed X Walk2?	N/A	
	X Walk 1 Direction	To S		X Wa	lk 2 Direction	N/A	
N/A	X Walk 1 Width (in)	N/A	N/A	X Wa	lk 2 Width (in)	N/A

X Walk 1 Slope (%)	4.0		X Wa	lk 2 Slope (%)	N/A	
	X Walk 1 X Slope (%)	4.6		X Wa	lk 2 X Slope (%)	N/A	
N/A	Ramp inside XWalk1?	N/A	N/A	Ramp	inside XWalk2?	N/A	
	Road Slope (%)	N/A	N/A	Clear	Space?	N/A	
	Road X Slope (%)	N/A	N/A	Clear	Space to XWalk (in)	N/A	
N/A	Any Obstructions?	N/A	N/A	Storm	Grate/Utility Hazard?	N/A	
	Obstruction Type			Storm	Grate/Utility Type		
		N/A				N/A	
			Yes	Surfa	ce Condition? (G/P)	Good

1 033ibic Goldtions.						
Remove & Replace Entire Ramp.						
Surveyor Notes:						
N/A						
N/A						
PROW/ADA:						
Not Found, R304.5.1, R304.2.2, R304.5.3
