Access Compliance Report Public Rights-of-Way (Curb Ramps)

Intersection ID: 25958 Main Street: KINGFISHER_DR Cross Street: PARK_RD Location: NE

ADA ID: C95F467BF11F Ramp Type: PerpDiag Initial Pass/Fail: Fail Overall Compliance: No Severity Score: 33.75

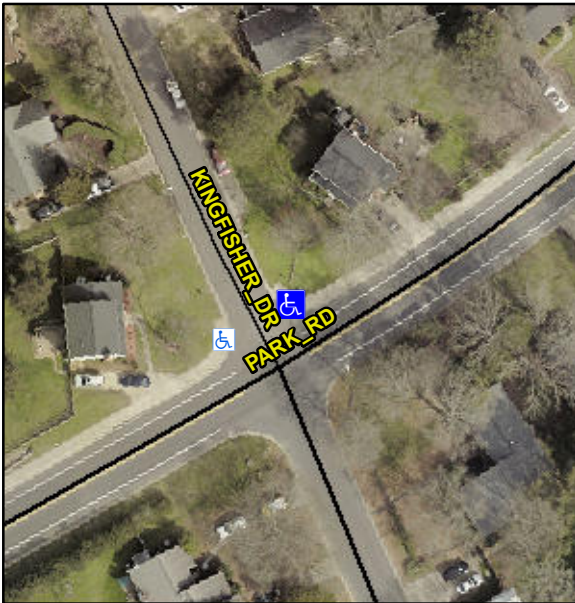
PROW/ADA:
Not Found, R304.5.1, R304.5.3

| Compliance | Description | Data | Compliance | Description | Data |
|---|---|---|---|---|---|
| N/A | Ramp Length (in) | 70.0 | Yes | Ramp Slope (%) | 7.3 |
| No | Ramp Width (in) | 47.0 | No | Ramp XSlope (%) | 7.9 |

Possible Solutions:
Remove & Replace Curb Ramp With Two New Directional Ramps or Equivalent.

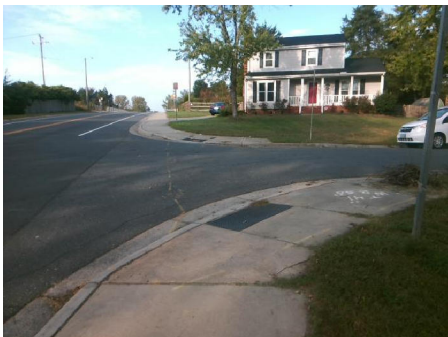
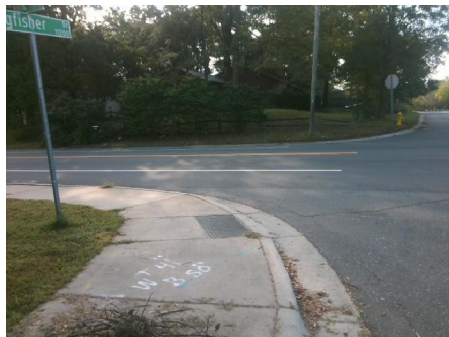
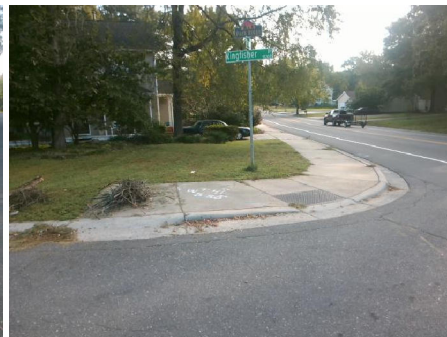
Street 1 Name **KINGFISHER DR**
 Stop Condition-Street 2 **StopSign**
 Street 2 Name **PARK RD**
 Stop Condition-Street 1 **None**
