# Access Compliance Report

## Public Rights-of-Way

### (Curb Ramps)

Intersection ID: 15116	Main Street: EUCLID_AV	Cross Street: IDEAL_WY	Location: E
ADA ID: C9715974CDD8	Ramp Type: Directional1	Initial Pass/Fail: Fail	Overall Compliance: No
		Severity Score: 12.5

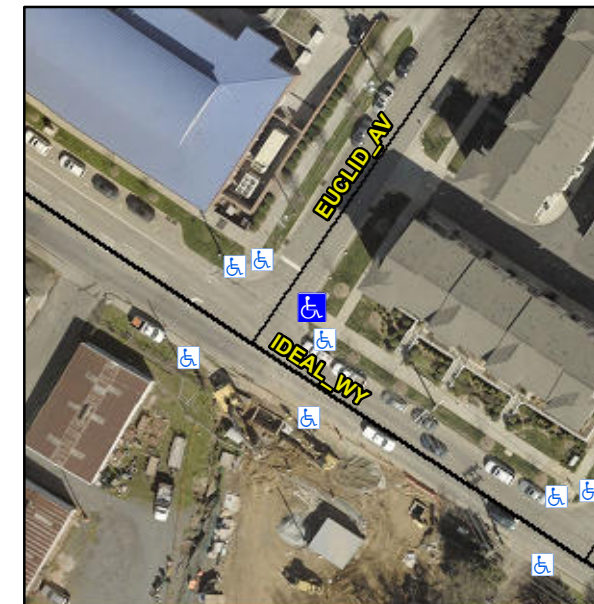
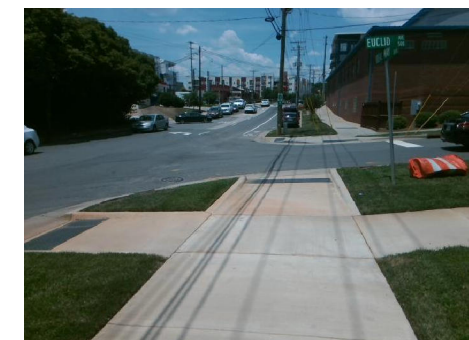
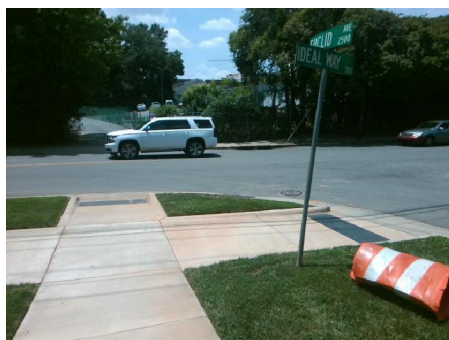
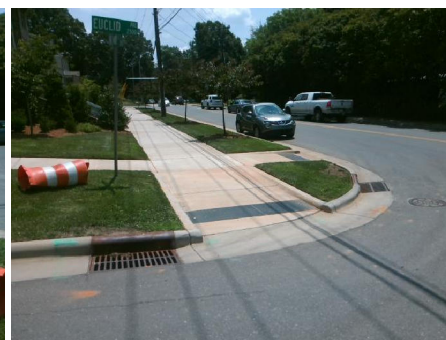
Compliance	Description	Data	Compliance	Description	Data
N/A	Ramp Length (in)	96.0	N/A	Grade Break?	N/A
Yes	Ramp Width (in)	88.0	N/A	Grade Break Slope (%)	0.0
Yes	Ramp Slope (%)	6.1	N/A	Grade Break XSlope (%)	0.0
No	Ramp XSlope (%)	5.2			
N/A	Flare Type LT	N/A	N/A	Flare Type RT	N/A
N/A	Flare Slope LT (%)	N/A	N/A	Flare Slope RT (%)	0.0
N/A	Flare Traversable LT?	N/A	N/A	Flare Traversable RT?	N/A
N/A	Landing Length (in)	0.0	N/A	DWS Provided?	N/A
N/A	Landing Width (in)	0.0	N/A	DWS Contrast?	N/A
N/A	Landing Slope (%)	0.0	N/A	DWS Length (in)	N/A
N/A	Landing X Slope (%)	0.0	N/A	DWS Full Width?	N/A
N/A	Landing Curb? (Y/N)	N/A	N/A	DWS Offset LT (in)	N/A
N/A	Shared Landing?	N/A	N/A	DWS Offset RT (in)	N/A
N/A	Gutter Ponding?	0.0	N/A	Gutter Slope (%)	N/A
N/A	Gutter Lip Ht (in)	0.0	N/A	Gutter X Slope (%)	N/A
N/A	Painted X Walk1?	No		Road Slope (%)	4.3
	X Walk 1 Direction	To NW		Road X Slope (%)	7.1
	X Walk 1 Width (in)	N/A		Clear Space?	N/A

X Walk 1 Slope (%)	4.3	N/A	Clear Space to XWalk (in)	N/A
	X Walk 1 X Slope (%)	7.1	N/A	Storm Grate/Utility Hazard?	N/A
N/A	Ramp inside XWalk1?	N/A		Storm Grate/Utility Type	
N/A	Any Obstructions?	N/A			N/A
	Obstruction Type		Yes	Surface Condition? (G/P)	Good
			N/A	Curb Slope (%)	9.9

**Remove & Replace Entire Ramp.**

**R304.5.3**
