## **Access Compliance Report Public Rights-of-Way** (Curb Ramps)

Intersection ID: N/A Main Street: WILKINSON\_BV Cross Street: BARRY\_DR Location: SW **Overall Compliance: No** ADA ID: C97BA215293A Ramp Type: Perp Initial Pass/Fail: Fail Severity Score: 46.25

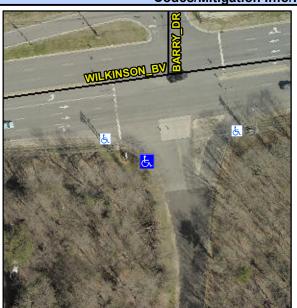
Field Measurements/Component Compliance						
Comp	liance Description	Data	Comp	liance	Description	Data
N/A	Ramp Length (in)	60.0	No	Ramp	Slope (%)	8.9
No	Ramp Width (in)	46.0	No	Ramp	XSlope (%)	9.0
N/A	Flare Type LT	N/A	N/A	Flare	Type RT	N/A
N/A	Flare Slope LT (%)	N/A	N/A	Flare	Slope RT (%)	N/A
N/A	Flare Traversable LT?	N/A	N/A	Flare	Traversable RT?	N/A
N/A	Landing Length (in)	N/A	N/A	DWS	Provided?	N/A
N/A	Landing Width (in)	N/A	N/A	DWS	Contrast?	N/A
N/A	Landing Slope (%)	N/A	N/A	DWS	Length (in)	N/A
N/A	Landing X Slope (%)	N/A	N/A	DWS	Full Width?	N/A
N/A	Landing Curb? (Y/N)	N/A	N/A	DWS	Offset (in)	N/A
N/A	Shared Landing?	N/A				
N/A	Gutter Ponding?	N/A	N/A	Gutte	er Slope (%)	N/A
N/A	Gutter Lip Ht (in)	N/A	N/A	Gutte	r X Slope (%)	N/A
N/A	Painted X Walk1?	No	N/A	Paint	ed X Walk2?	N/A
	X Walk 1 Direction	То Е		X Wa	lk 2 Direction	N/A
N/A	X Walk 1 Width (in)	N/A	N/A	X Wa	lk 2 Width (in)	N/A
	X Walk 1 Slope (%)	8.0		X Wa	lk 2 Slope (%)	N/A

COSIDIC COIGUON
Possible Solutions:
Remove & Replace Entire Ramp.
Oursell Notes
Surveyor Notes:
N/A
PROW/ADA:
Not Found, R304.5.1, R304.2.2, R304.5.3
1304.3.3
