Access Compliance Report

Public Rights-of-Way

(Curb Ramps)

Intersection ID: 48999	Main Street: STEELECROFT_FARM_LN	Cross Street: STEELECROFT_PY	Location: NW
ADA ID: C97F012A91F3	Ramp Type: MedianPerp	Initial Pass/Fail: Fail	Overall Compliance: No
		Severity Score: 12.5	
Codes/Mitigation Info/Possible Solution		Field Measurements/Component Compliance

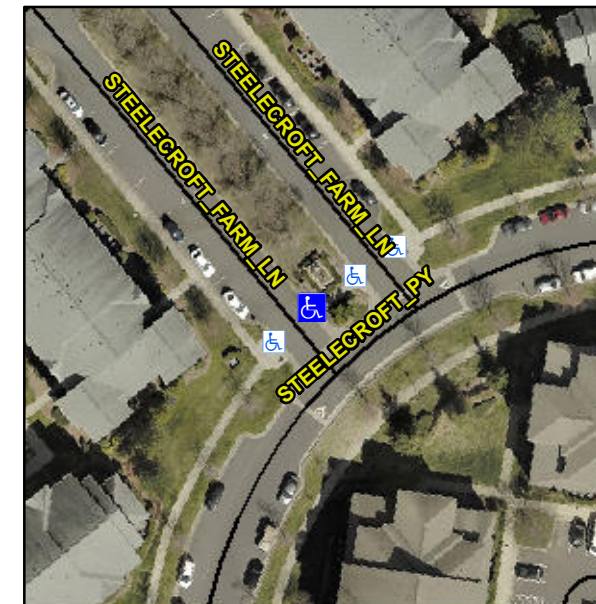
Not Found, R304.2.2

Compliance	Description	Data	Compliance	Description	Data
N/A	Ramp Length (in)	61.0	No	Ramp Slope (%)	8.7
Yes	Ramp Width (in)	49.0	Yes	Ramp XSlope (%)	0.4
N/A	Flare Type LT	N/A	N/A	Flare Type RT	N/A
N/A	Flare Slope LT (%)	N/A	N/A	Flare Slope RT (%)	N/A
N/A	Flare Traversable LT?	N/A	N/A	Flare Traversable RT?	N/A
N/A	Landing Length (in)	N/A	N/A	DWS Provided?	N/A
N/A	Landing Width (in)	N/A	N/A	DWS Contrast?	N/A
N/A	Landing Slope (%)	N/A	N/A	DWS Length (in)	N/A
N/A	Landing X Slope (%)	N/A	N/A	DWS Full Width?	N/A
N/A	Landing Curb? (Y/N)	N/A	N/A	DWS Offset (in)	N/A
N/A	Shared Landing?	N/A			
N/A	Gutter Ponding?	N/A	N/A	Gutter Slope (%)	N/A
N/A	Gutter Lip Ht (in)	N/A	N/A	Gutter X Slope (%)	N/A
N/A	Painted X Walk1?	No	N/A	Painted X Walk2?	N/A
	X Walk 1 Direction	To W		X Walk 2 Direction	N/A
N/A	X Walk 1 Width (in)	N/A	N/A	X Walk 2 Width (in)	N/A
	X Walk 1 Slope (%)	2.7		X Walk 2 Slope (%)	N/A
	X Walk 1 X Slope (%)	0.5		X Walk 2 X Slope (%)	N/A

Remove & Replace Entire Ramp.

Total Cost: \$ 1650.00
