Intersection ID: 29376	Main Street: BOARS_HEAD_CT	Cross Street: BUCKVALLEY_DR	Location:	SW
ADA ID: C985B68AC9E4	Ramp Type: PerpDiag	Initial Pass/Fail: Fail	Overall Compliance: No	Severity Score: 46.25

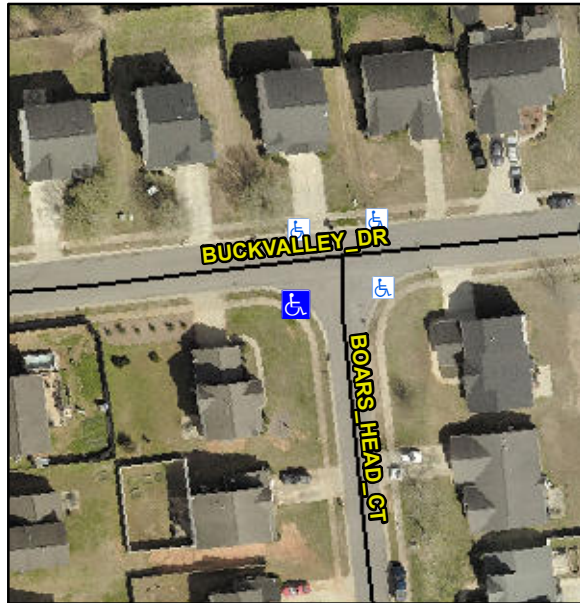
**Not Found, R304.5.1, R304.2.2,  
R304.5.3**

Compliance	Description	Data	Compliance	Description	Data
N/A	Ramp Length (in)	93.0	No	Ramp Slope (%)	8.7
No	Ramp Width (in)	47.0	No	Ramp XSlope (%)	13.7
N/A	Flare Type LT	N/A	N/A	Flare Type RT	N/A
N/A	Flare Slope LT (%)	N/A	N/A	Flare Slope RT (%)	N/A
N/A	Flare Traversable LT?	N/A	N/A	Flare Traversable RT?	N/A
N/A	Landing Length (in)	N/A	N/A	DWS Provided?	N/A
N/A	Landing Width (in)	N/A	N/A	DWS Contrast?	N/A
N/A	Landing Slope (%)	N/A	N/A	DWS Length (in)	N/A
N/A	Landing X Slope (%)	N/A	N/A	DWS Full Width?	N/A
N/A	Landing Curb? (Y/N)	N/A	N/A	DWS Offset (in)	N/A
N/A	Shared Landing?	N/A			
N/A	Gutter Ponding?	N/A	N/A	Gutter Slope (%)	N/A
N/A	Gutter Lip Ht (in)	N/A	N/A	Gutter X Slope (%)	N/A
N/A	Painted X Walk1?	No	N/A	Painted X Walk2?	No
	X Walk 1 Direction	To E		X Walk 2 Direction	To N
N/A	X Walk 1 Width (in)	N/A	N/A	X Walk 2 Width (in)	N/A
	X Walk 1 Slope (%)	3.1		X Walk 2 Slope (%)	7.3
	X Walk 1 X Slope (%)	6.4		X Walk 2 X Slope (%)	7.8

N/A	Ramp inside XWalk1?	N/A	N/A	Ramp inside XWalk2?	N/A
	Road Slope (%)	10.5	N/A	Clear Space?	N/A
	Road X Slope (%)	0.1	N/A	Clear Space to XWalk (in)	N/A
N/A	Any Obstructions?	N/A	N/A	Storm Grate/Utility Hazard?	N/A
	Obstruction Type			Storm Grate/Utility Type	
		N/A			N/A
			Yes	Surface Condition? (G/P)	Good

**Remove & Replace Curb Ramp With Two New Directional Ramps or Equivalent.**
