# Access Compliance Report

## Public Rights-of-Way

### (Curb Ramps)

Intersection ID: N/A	Main Street: SOUTHSTREAM_BV	Cross Street: N/A	Location: NW
ADA ID: C98AB7878F4A	Ramp Type: PerpDiag	Initial Pass/Fail: Fail	Overall Compliance: No
		Severity Score: 25

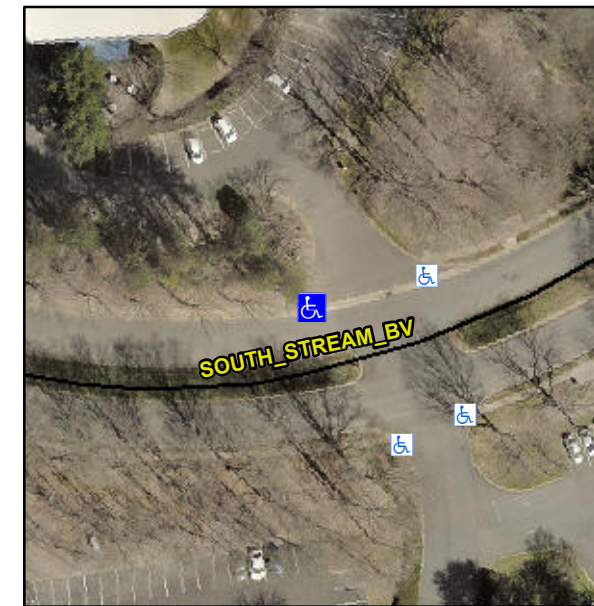
**Not Found, R304.2.2, R304.5.3**

Compliance	Description	Data	Compliance	Description	Data
N/A	Ramp Length (in)	60.0	No	Ramp Slope (%)	11.4
Yes	Ramp Width (in)	61.0	No	Ramp XSlope (%)	5.5
N/A	Flare Type LT	N/A	N/A	Flare Type RT	N/A
N/A	Flare Slope LT (%)	N/A	N/A	Flare Slope RT (%)	N/A
N/A	Flare Traversable LT?	No	N/A	Flare Traversable RT?	No
N/A	Landing Length (in)	N/A	N/A	DWS Provided?	N/A
N/A	Landing Width (in)	N/A	N/A	DWS Contrast?	N/A
N/A	Landing Slope (%)	N/A	N/A	DWS Length (in)	N/A
N/A	Landing X Slope (%)	N/A	N/A	DWS Full Width?	N/A
N/A	Landing Curb? (Y/N)	N/A	N/A	DWS Offset (in)	N/A
N/A	Shared Landing?	N/A			
N/A	Gutter Ponding?	N/A	N/A	Gutter Slope (%)	N/A
N/A	Gutter Lip Ht (in)	N/A	N/A	Gutter X Slope (%)	N/A
N/A	Painted X Walk1?	No	N/A	Painted X Walk2?	No
	X Walk 1 Direction	To S		X Walk 2 Direction	To E
N/A	X Walk 1 Width (in)	N/A	N/A	X Walk 2 Width (in)	N/A
	X Walk 1 Slope (%)	2.0		X Walk 2 Slope (%)	6.5
	X Walk 1 X Slope (%)	6.5		X Walk 2 X Slope (%)	0.2

N/A	Ramp inside XWalk1?	N/A	N/A	Ramp inside XWalk2?	N/A
	Road Slope (%)	6.1	N/A	Clear Space?	N/A
	Road X Slope (%)	3.5	N/A	Clear Space to XWalk (in)	N/A
N/A	Any Obstructions?	N/A	N/A	Storm Grate/Utility Hazard?	N/A
	Obstruction Type			Storm Grate/Utility Type	
		N/A			N/A
			Yes	Surface Condition? (G/P)	Good

**Remove & Replace Curb Ramp With Two New Directional Ramps or Equivalent.**

Total Cost: \$ 3200.00
