Access Compliance Report Public Rights-of-Way (Curb Ramps)

| Intersection ID: N/A | Main Street: ELEANOR_RIGBY_RD | Cross Street: MAGGIE_MAY_LN | Location: NE |
| ADA ID: C98D946FF293 | Ramp Type: Perp | Initial Pass/Fail: Fail | Overall Compliance: No |

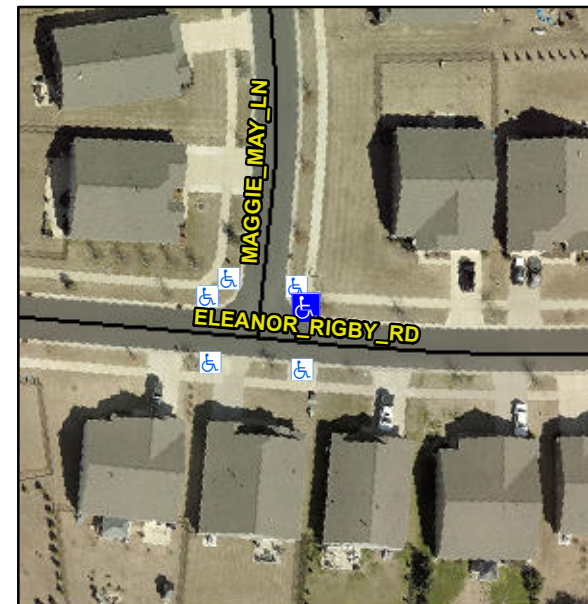
Not Found, R304.5.1, R304.5.3

| Compliance | Description | Data | Compliance | Description | Data |
|---|---|---|---|---|---|
| No | Ramp Width (in) | 47.0 | No | Ramp XSlope (%) | 3.2 |

Remove & Replace Entire Ramp.
