Access Compliance Report Public Rights-of-Way (Curb Ramps)

Intersection ID: 10034319 Main Street: PERIMETER PY **Cross Street: N/A** Location: SW Initial Pass/Fail: Fail **ADA ID: C98F12BDD577** Ramp Type: PerpDiag **Overall Compliance: No Severity Score:** 25

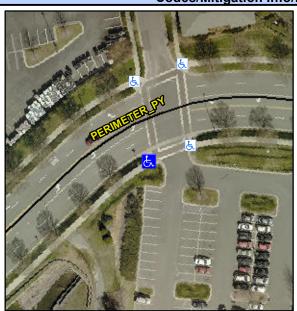
Field Measurements/Component Compliance					
Compliance Description		Data	Comp	liance Description	Data
N/A	Ramp Length (in)	72.0	Yes	Ramp Slope (%)	6.4
Yes	Ramp Width (in)	48.0	No	Ramp XSlope (%)	7.4
N/A	Flare Type LT	N/A	N/A	Flare Type RT	N/A
N/A	Flare Slope LT (%)	N/A	N/A	Flare Slope RT (%)	N/A
N/A	Flare Traversable LT?	N/A	N/A	Flare Traversable RT?	N/A
N/A	Landing Length (in)	N/A	N/A	DWS Provided?	N/A
N/A	Landing Width (in)	N/A	N/A	DWS Contrast?	N/A
N/A	Landing Slope (%)	N/A	N/A	DWS Length (in)	N/A
N/A	Landing X Slope (%)	N/A	N/A	DWS Full Width?	N/A
N/A	Landing Curb? (Y/N)	N/A	N/A	DWS Offset (in)	N/A
N/A	Shared Landing?	N/A			
N/A	Gutter Ponding?	N/A	N/A	Gutter Slope (%)	N/A
N/A	Gutter Lip Ht (in)	N/A	N/A	Gutter X Slope (%)	N/A
N/A	Painted X Walk1?	Yes	N/A	Painted X Walk2?	Yes
	X Walk 1 Direction	То Е		X Walk 2 Direction	To N
N/A	X Walk 1 Width (in)	71.0	N/A	X Walk 2 Width (in)	71.0
	X Walk 1 Slope (%)	2.2		X Walk 2 Slope (%)	4.8

X Walk 1 X Slope (%)	9.4		X Walk 2 X Slope (%)	1.4
N/A	Ramp inside XWalk1?	Yes	N/A	Ramp inside XWalk2?	Yes
	Road Slope (%)	6.0	N/A	Clear Space?	N/A
	Road X Slope (%)	4.9	N/A	Clear Space to XWalk (in)	N/A
N/A	Any Obstructions?	N/A	N/A	Storm Grate/Utility Hazard?	N/A
	Obstruction Type			Storm Grate/Utility Type	
		N/A			N/A
			Yes	Surface Condition? (G/P)	Good
L X	ALICE TO A APPLICATION OF THE PARTY OF THE P

ENTRANCE StopSign **PERIMETER PY** None Possible Solutions: Remove & Replace Curb Ramp With **Two New Directional Ramps or** Equivalent. Surveyor Notes: N/A PROW/ADA: Not Found, R304.5.3
