# Access Compliance Report

## Public Rights-of-Way

### (Curb Ramps)

Intersection ID: 31894	Main Street: GREEN_MOUNTAIN_RD	Cross Street: MOUNTAIN_SPRINGS_DR	Location:	N
ADA ID: C99A2C15662A	Ramp Type: BlendTrans1	Initial Pass/Fail: Fail	Overall Compliance: No	Severity Score: 10
Codes/Mitigation Info/Possible Solution		Field Measurements/Component Compliance

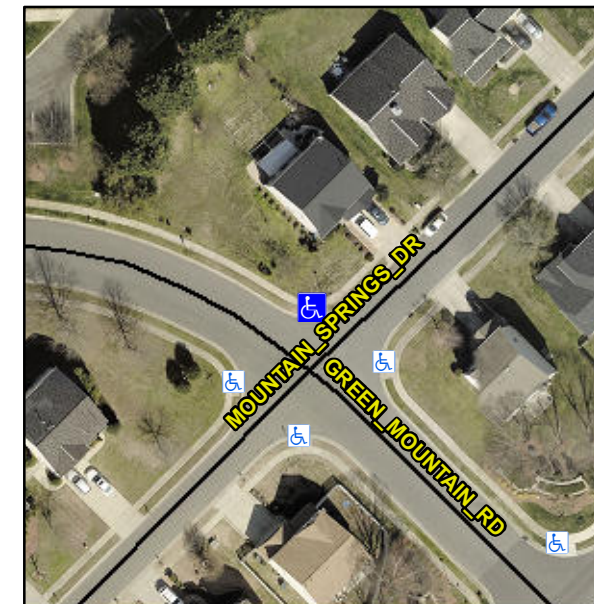
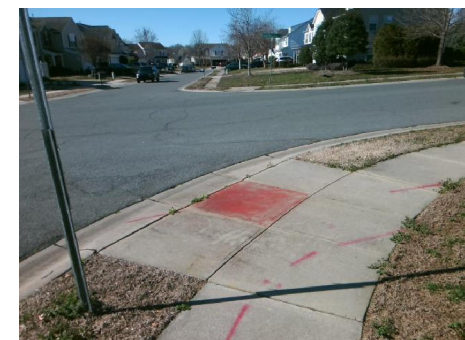
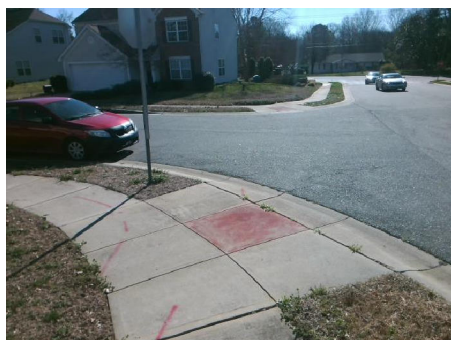
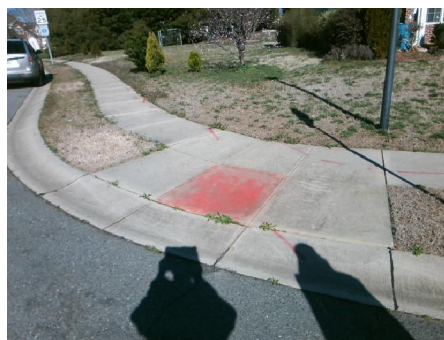
PROW/ADA:

**R304.5.1, R304.5.3**

Compliance	Description	Data	Compliance	Description	Data
N/A	Ramp Length (in)	47.5	Yes	BlendTrans Slope (%)	4.5
No	Ramp Width (in)	40.5	No	BlendTrans XSlope (%)	3.4
N/A	Flare Type LT	N/A	N/A	Flare Type RT	N/A
N/A	Flare Slope LT (%)	N/A	N/A	Flare Slope RT (%)	N/A
N/A	Flare Traversable LT?	N/A	N/A	Flare Traversable RT?	N/A
N/A	Landing Length (in)	N/A	N/A	DWS Provided?	N/A
N/A	Landing Width (in)	N/A	N/A	DWS Contrast?	N/A
N/A	Landing Slope (%)	N/A	N/A	DWS Length (in)	N/A
N/A	Landing X Slope (%)	N/A	N/A	DWS Full Width?	N/A
N/A	Landing Curb? (Y/N)	N/A	N/A	DWS Offset (in)	N/A
N/A	Shared Landing?	N/A			
N/A	Gutter Ponding?	N/A	N/A	Gutter Slope (%)	N/A
N/A	Gutter Lip Ht (in)	N/A	N/A	Gutter X Slope (%)	N/A
N/A	Painted X Walk1?	No	N/A	Painted X Walk2?	No
	X Walk 1 Direction	To SW		X Walk 2 Direction	To SE
	X Walk 1 Width (in)	N/A		X Walk 2 Width (in)	N/A
	X Walk 1 Slope (%)	0.6		X Walk 2 Slope (%)	3.7
	X Walk 1 X Slope (%)	1.9		X Walk 2 X Slope (%)	0.9

N/A	Ramp inside XWalk1?	N/A	N/A	Ramp inside XWalk2?	N/A
	Road Slope (%)	2.8		Clear Space?	N/A
	Road X Slope (%)	2.6	N/A	Clear Space to XWalk (in)	N/A
N/A	Any Obstructions?	N/A	N/A	Storm Grate/Utility Hazard?	N/A
	Obstruction Type			Storm Grate/Utility Type	
		N/A			N/A
			Yes	Surface Condition? (G/P)	Good
			N/A	Curb Slope (%)	3.2

Possible Solutions:

**Remove & Replace Curb Ramp With Two New Directional Ramps or Equivalent.**

Total Cost: \$ 3200.00
