# Access Compliance Report

## Public Rights-of-Way

### (Curb Ramps)

Intersection ID: 20639	Main Street: CROWN_VIEW_DR	Cross Street: TOWER_POINT_DR	Location:	N
ADA ID: C9AD84297419	Ramp Type: PerpDiag	Initial Pass/Fail: Fail	Overall Compliance: No	Severity Score: 12.5

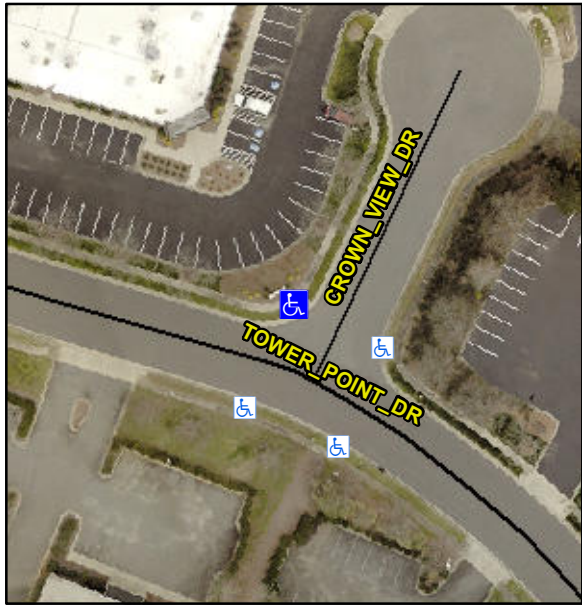
Possible Solutions:		Compliance	Description	Data	Compliance	Description	Data
	Remove & Replace Curb Ramp With Two New Directional Ramps or Equivalent.		N/A	Ramp Length (in)	63.5	Yes	Ramp Slope (%)	5.4
			Yes	Ramp Width (in)	51.0	No	Ramp XSlope (%)	5.2
			N/A	Flare Type LT	N/A	N/A	Flare Type RT	N/A
			N/A	Flare Slope LT (%)	N/A	N/A	Flare Slope RT (%)	N/A
			N/A	Flare Traversable LT?	N/A	N/A	Flare Traversable RT?	N/A
			N/A	Landing Length (in)	N/A	N/A	DWS Provided?	N/A
			N/A	Landing Width (in)	N/A	N/A	DWS Contrast?	N/A
			N/A	Landing Slope (%)	N/A	N/A	DWS Length (in)	N/A
			N/A	Landing X Slope (%)	N/A	N/A	DWS Full Width?	N/A
Surveyor Notes:		N/A	N/A	Landing Curb? (Y/N)	N/A	N/A	DWS Offset (in)	N/A
			N/A	Shared Landing?	N/A			
PROW/ADA:		Not Found, R304.5.3	N/A	Gutter Ponding?	N/A	N/A	Gutter Slope (%)	N/A
			N/A	Gutter Lip Ht (in)	N/A	N/A	Gutter X Slope (%)	N/A

N/A	Painted X Walk1?	No	N/A	Painted X Walk2?	No
				X Walk 1 Direction	To SW		X Walk 2 Direction	To SE
			N/A	X Walk 1 Width (in)	N/A	N/A	X Walk 2 Width (in)	N/A
				X Walk 1 Slope (%)	5.2		X Walk 2 Slope (%)	6.5
				X Walk 1 X Slope (%)	2.2		X Walk 2 X Slope (%)	3.5
			N/A	Ramp inside XWalk1?	N/A	N/A	Ramp inside XWalk2?	N/A
				Road Slope (%)	1.3	N/A	Clear Space?	N/A
				Road X Slope (%)	3.2	N/A	Clear Space to XWalk (in)	N/A
			N/A	Any Obstructions?	N/A	N/A	Storm Grate/Utility Hazard?	N/A
				Obstruction Type			Storm Grate/Utility Type	
					N/A			N/A
						Yes	Surface Condition? (G/P)	Good
