Access Compliance Report

Public Rights-of-Way

(Curb Ramps)

| Intersection ID: 48312 | Main Street: ROCKY_BROOK_CT | Cross Street: TRILLIUM_FIELDS_DR | Location: SE |

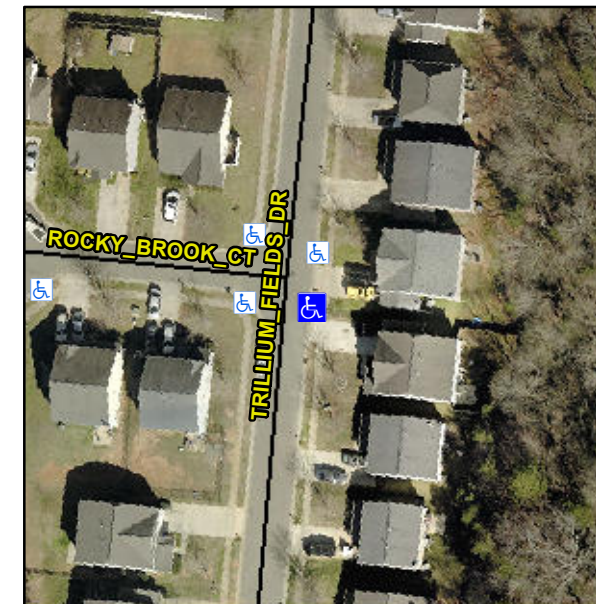
R304.5.3, R304.2.1, R305.2

| Compliance | Description | Data | Compliance | Description | Data |
|---|---|---|---|---|---|
| Yes | Ramp Width (in) | 48.0 | No | Ramp XSlope (%) | 4.5 |
| No | Landing Length (in) | 47.5 | Yes | DWS Provided? | Yes |
| N/A | Landing Curb? (Y/N) | No | No | DWS Offset (in) | 4.0 |

Remove & Replace Entire Ramp.

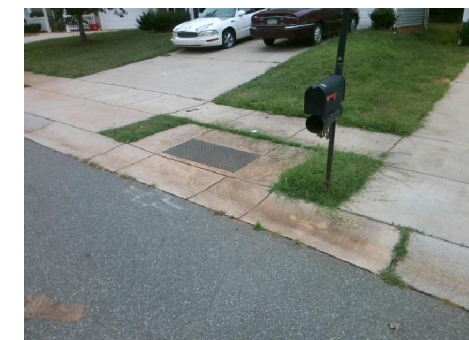
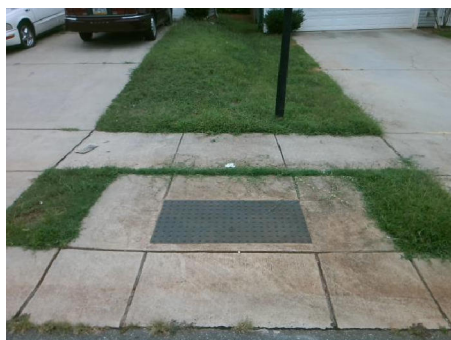
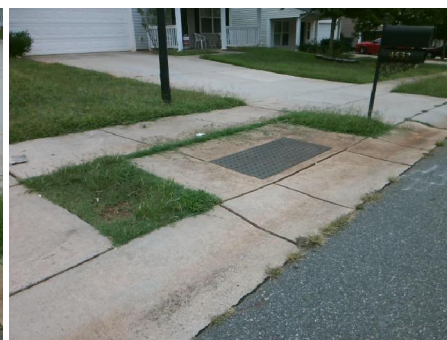
| Compliance | Description | Data | Compliance | Description | Data |
|---|---|---|---|---|---|
| | | | Yes | Surface Condition? (G/P) | Good |
