Access Compliance Report

Public Rights-of-Way

(Curb Ramps)

Intersection ID: 18000	Main Street: PROVIDENCE_RD	Cross Street: ANDOVER_RD	Location: NE
ADA ID: C9C31C48E74A	Ramp Type: PerpDiag	Initial Pass/Fail: Fail	Overall Compliance: No
			Severity Score: 21.25

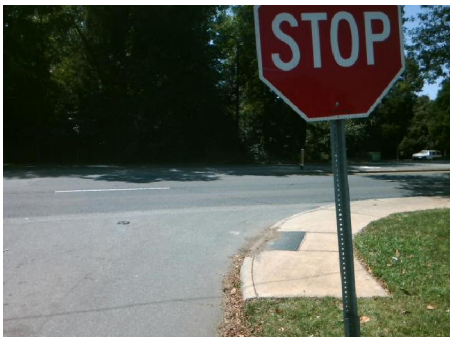
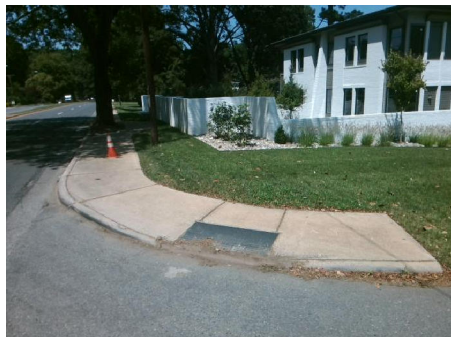
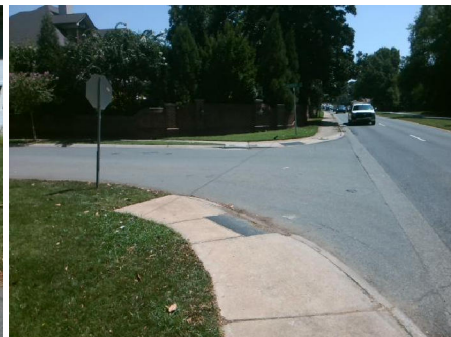
Compliance	Description	Data	Compliance	Description	Data
N/A	Ramp Length (in)	60.0	No	Ramp Slope (%)	10.3
No	Ramp Width (in)	40.0	Yes	Ramp XSlope (%)	1.6
N/A	Flare Type LT	N/A	N/A	Flare Type RT	N/A
N/A	Flare Slope LT (%)	N/A	N/A	Flare Slope RT (%)	N/A
N/A	Flare Traversable LT?	N/A	N/A	Flare Traversable RT?	N/A
N/A	Landing Length (in)	N/A	N/A	DWS Provided?	N/A
N/A	Landing Width (in)	N/A	N/A	DWS Contrast?	N/A
N/A	Landing Slope (%)	N/A	N/A	DWS Length (in)	N/A
N/A	Landing X Slope (%)	N/A	N/A	DWS Full Width?	N/A
N/A	Landing Curb? (Y/N)	N/A	N/A	DWS Offset (in)	N/A
N/A	Shared Landing?	N/A			
N/A	Gutter Ponding?	Yes	N/A	Gutter Slope (%)	N/A
N/A	Gutter Lip Ht (in)	N/A	N/A	Gutter X Slope (%)	N/A
N/A	Painted X Walk1?	No	N/A	Painted X Walk2?	No
	X Walk 1 Direction	To SW		X Walk 2 Direction	To SE
N/A	X Walk 1 Width (in)	N/A	N/A	X Walk 2 Width (in)	N/A
	X Walk 1 Slope (%)	2.4		X Walk 2 Slope (%)	3.2
	X Walk 1 X Slope (%)	2.4		X Walk 2 X Slope (%)	2.4

N/A	Ramp inside XWalk1?	N/A	N/A	Ramp inside XWalk2?	N/A
	Road Slope (%)	1.7	N/A	Clear Space?	N/A
	Road X Slope (%)	6.3	N/A	Clear Space to XWalk (in)	N/A
N/A	Any Obstructions?	N/A	N/A	Storm Grate/Utility Hazard?	N/A
	Obstruction Type			Storm Grate/Utility Type	
		N/A			N/A
			Yes	Surface Condition? (G/P)	Good

Possible Solutions:				
	Remove & Replace Curb Ramp With Two New Directional Ramps or Equivalent.				
	Surveyor Notes:				
	N/A				
	PROW/ADA:				
	R304.5.1, R304.2.2				
Street 1 Name	PROVIDENCE RD				
Stop Condition-Street 2	None				
Street 2 Name	ANDOVER RD				
Stop Condition-Street 1	StopSign				
Total Cost:		\$	3200.00
