Access Compliance Report

Public Rights-of-Way

(Curb Ramps)

Intersection ID: 26112	Main Street: COLONIAL HEIGHTS DR	Cross Street: ELM LN	Location: SW
ADA ID: C9CE953720F1	Ramp Type: Perp	Initial Pass/Fail: Fail	Overall Compliance: No
Severity Score: 22.5			
Codes/Mitigation Info/Possible Solution		Field Measurements/Component Compliance

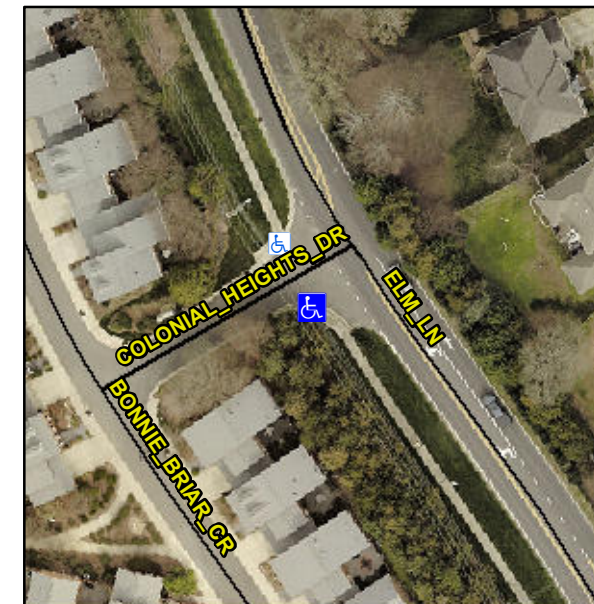
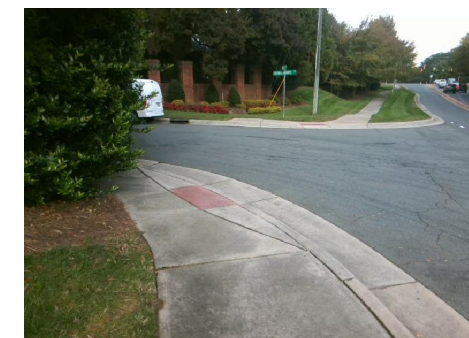
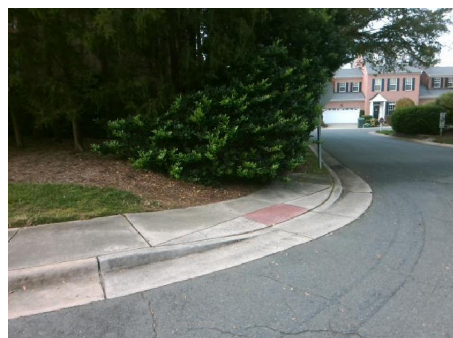
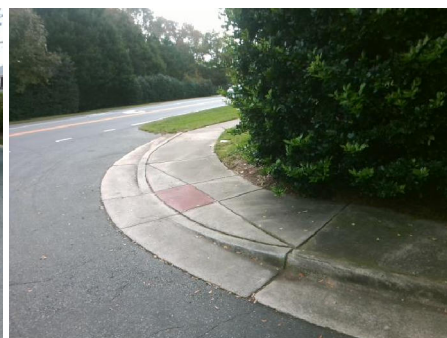
R304.5.1, R304.2.2, R304.5.3

Compliance	Description	Data	Compliance	Description	Data
N/A	Ramp Length (in)	59.0	No	Ramp Slope (%)	9.1
No	Ramp Width (in)	39.0	No	Ramp XSlope (%)	2.5
N/A	Flare Type LT	N/A	N/A	Flare Type RT	N/A
N/A	Flare Slope LT (%)	N/A	N/A	Flare Slope RT (%)	N/A
N/A	Flare Traversable LT?	N/A	N/A	Flare Traversable RT?	N/A
N/A	Landing Length (in)	N/A	N/A	DWS Provided?	N/A
N/A	Landing Width (in)	N/A	N/A	DWS Contrast?	N/A
N/A	Landing Slope (%)	N/A	N/A	DWS Length (in)	N/A
N/A	Landing X Slope (%)	N/A	N/A	DWS Full Width?	N/A
N/A	Landing Curb? (Y/N)	N/A	N/A	DWS Offset (in)	N/A
N/A	Shared Landing?	N/A			
N/A	Gutter Ponding?	N/A	N/A	Gutter Slope (%)	N/A
N/A	Gutter Lip Ht (in)	N/A	N/A	Gutter X Slope (%)	N/A
N/A	Painted X Walk1?	No	N/A	Painted X Walk2?	N/A
	X Walk 1 Direction	To N		X Walk 2 Direction	N/A
N/A	X Walk 1 Width (in)	N/A	N/A	X Walk 2 Width (in)	N/A
	X Walk 1 Slope (%)	2.0		X Walk 2 Slope (%)	N/A
	X Walk 1 X Slope (%)	2.4		X Walk 2 X Slope (%)	N/A

N/A	Ramp inside XWalk1?	N/A	N/A	Ramp inside XWalk2?	N/A
	Road Slope (%)	N/A	N/A	Clear Space?	N/A
	Road X Slope (%)	N/A	N/A	Clear Space to XWalk (in)	N/A
N/A	Any Obstructions?	N/A	N/A	Storm Grate/Utility Hazard?	N/A
	Obstruction Type			Storm Grate/Utility Type	
		N/A			N/A
			Yes	Surface Condition? (G/P)	Good

Remove & Replace Entire Ramp.
