# Access Compliance Report

## Public Rights-of-Way

### (Curb Ramps)

Intersection ID: 12896	Main Street: E_6TH_ST	Cross Street: N_MCDOWELL_ST	Location: N
ADA ID: C9E34B9A55F4	Ramp Type: BlendTrans1	Initial Pass/Fail: Fail	Overall Compliance: No
Severity Score: 12.5			
Codes/Mitigation Info/Possible Solution		Field Measurements/Component Compliance

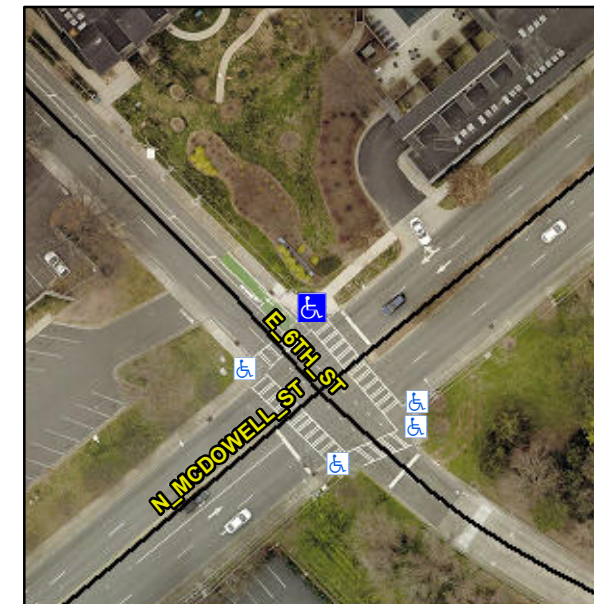
Compliance	Description	Data	Compliance	Description	Data
N/A	Ramp Length (in)	80.0	Yes	BlendTrans Slope (%)	2.4
Yes	Ramp Width (in)	130.0	No	BlendTrans XSlope (%)	5.6
N/A	Flare Type LT	N/A	N/A	Flare Type RT	N/A
N/A	Flare Slope LT (%)	N/A	N/A	Flare Slope RT (%)	N/A
N/A	Flare Traversable LT?	N/A	N/A	Flare Traversable RT?	N/A
N/A	Landing Length (in)	N/A	N/A	DWS Provided?	N/A
N/A	Landing Width (in)	N/A	N/A	DWS Contrast?	N/A
N/A	Landing Slope (%)	N/A	N/A	DWS Length (in)	N/A
N/A	Landing X Slope (%)	N/A	N/A	DWS Full Width?	N/A
N/A	Landing Curb? (Y/N)	N/A	N/A	DWS Offset (in)	N/A
N/A	Shared Landing?	N/A			
N/A	Gutter Ponding?	N/A	N/A	Gutter Slope (%)	N/A
N/A	Gutter Lip Ht (in)	N/A	N/A	Gutter X Slope (%)	N/A
N/A	Painted X Walk1?	Yes	N/A	Painted X Walk2?	Yes
	X Walk 1 Direction	To SW		X Walk 2 Direction	To SE
	X Walk 1 Width (in)	91.0		X Walk 2 Width (in)	110.0
	X Walk 1 Slope (%)	0.5		X Walk 2 Slope (%)	3.5
	X Walk 1 X Slope (%)	5.2		X Walk 2 X Slope (%)	2.1

N/A	Ramp inside XWalk1?	Yes	N/A	Ramp inside XWalk2?	Yes
	Road Slope (%)	4.0		Clear Space?	N/A
	Road X Slope (%)	2.2	N/A	Clear Space to XWalk (in)	N/A
N/A	Any Obstructions?	N/A	N/A	Storm Grate/Utility Hazard?	N/A
	Obstruction Type			Storm Grate/Utility Type	
		N/A			N/A
		Yes		Surface Condition? (G/P)	Good
		No		Curb Slope (%)	12.8

Possible Solutions:

**Remove & Replace Curb Ramp With Two New Directional Ramps or Equivalent.**

**Not Found, R304.5.3**
