Access Compliance Report Public Rights-of-Way (Curb Ramps)

Intersection ID: N/A
 Main Street:
 MARKLAND_DR
 Cross Street:
 DENVIEW_LN
 Location:
 NE

ADA ID: C9E4508E23E8
 Ramp Type:
 PerpDiag
 Initial Pass/Fail:
 Pass
 Overall Compliance:
 No
 Severity Score:
 0

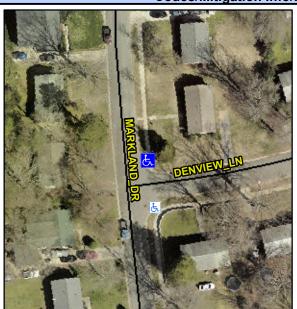
Field Measurements/Component Compliance						
	Compliance Description		Data	Compliance Description		Data
	N/A	Ramp Length (in)	73.0	Yes	Ramp Slope (%)	5.3
	Yes	Ramp Width (in)	48.0	Yes	Ramp XSlope (%)	0.7
	N/A	Flare Type LT	Sloped	N/A	Flare Type RT	N/A
	N/A	Flare Slope LT (%)	0.8	N/A	Flare Slope RT (%)	4.7
	N/A	Flare Traversable LT?	No	N/A	Flare Traversable RT?	No
	Yes	Landing Length (in)	60.0	Yes	DWS Provided?	Yes
	Yes	Landing Width (in)	48.0	Yes	DWS Contrast?	Yes
	Yes	Landing Slope (%)	1.7	Yes	DWS Length (in)	24.0
	Yes	Landing X Slope (%)	1.0	Yes	DWS Full Width?	Yes
	N/A	Landing Curb? (Y/N)	No	No	DWS Offset (in)	6.0
	N/A	Shared Landing?	No			
	Yes	Gutter Ponding?	No	Yes	Gutter Slope (%)	2.9
	Yes	Gutter Lip Ht (in)	0.0	Yes	Gutter X Slope (%)	0.6
	N/A	Painted X Walk1?	No	N/A	Painted X Walk2?	No
		X Walk 1 Direction	To W		X Walk 2 Direction	To S
	N/A	X Walk 1 Width (in)	N/A	N/A	X Walk 2 Width (in)	N/A
		X Walk 1 Slope (%)	2.6		X Walk 2 Slope (%)	3.9

X Walk 1 X Slope (%)	2.8		X Walk 2 X Slope (%)	2.5
	N/A	Ramp inside XWalk1?	N/A	N/A	Ramp inside XWalk2?	N/A
		Road Slope (%)	2.6	N/A	Clear Space?	Yes
		Road X Slope (%)	3.8	N/A	Clear Space to XWalk (in)	N/A
	Yes	Any Obstructions?	No	Yes	Storm Grate/Utility Hazard?	No
		Obstruction Type			Storm Grate/Utility Type	
			N/A			N/A
				Yes	Surface Condition? (G/P)	Good

Total Cost: \$ 3200.00
