## **Access Compliance Report Public Rights-of-Way** (Curb Ramps)

Intersection ID: 9326 Main Street: FAIRMONT ST **Cross Street: OAKLAWN AV** Location: S

Initial Pass/Fail: Fail **Overall Compliance: No Severity Score:** 25 ADA ID: C9F237B7B220 Ramp Type: Perp

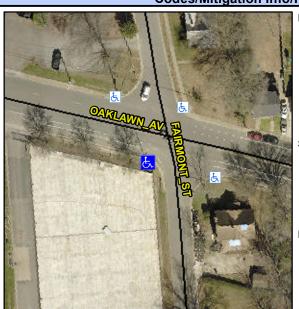
**FAIRMONT ST** Street 1 Name Stop Condition-Street 2 StopSign N/A Street 2 Name Stop Condition-Street 1 N/A Possible Solutions: Compliance Description N/A Remove & Replace Entire Ramp. Yes N/A N/A Surveyor Notes: N/A N/A N/A N/A N/A PROW/ADA: N/A Not Found, R304.2.2 N/A N/A N/A
