## **Access Compliance Report Public Rights-of-Way** (Curb Ramps)

Intersection ID: 10038782 Main Street: STEELE CREEK RD **Cross Street: N/A** Location: NW **Overall Compliance: No ADA ID: CA147D00A6D0** Ramp Type: PerpDiag Initial Pass/Fail: Fail **Severity Score:** 12.5

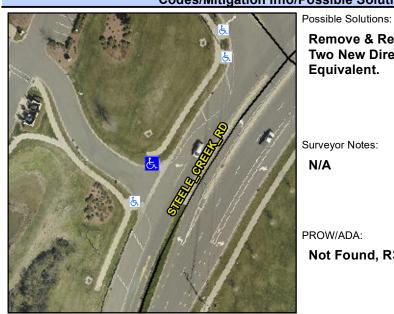
Comp	liance Description	Data	Comp	liance	Description	Data
N/A	Ramp Length (in)	94.0	No	Ramp	Slope (%)	8.9
Yes	Ramp Width (in)	48.0	Yes	Ramp	XSlope (%)	0.4
N/A	Flare Type LT	N/A	N/A	Flare	Type RT	N/A
N/A	Flare Slope LT (%)	N/A	N/A	Flare	Slope RT (%)	N/A
N/A	Flare Traversable LT?	N/A	N/A	Flare	Traversable RT?	N/A
N/A	Landing Length (in)	N/A	N/A	DWS	Provided?	N/A
N/A	Landing Width (in)	N/A	N/A	DWS	Contrast?	N/A
N/A	Landing Slope (%)	N/A	N/A	DWS	Length (in)	N/A
N/A	Landing X Slope (%)	N/A	N/A	DWS	Full Width?	N/A
N/A	Landing Curb? (Y/N)	N/A	N/A	DWS	Offset (in)	N/A
N/A	Shared Landing?	N/A				
N/A	Gutter Ponding?	N/A	N/A	Gutte	r Slope (%)	N/A
N/A	Gutter Lip Ht (in)	N/A	N/A	Gutte	r X Slope (%)	N/A
N/A	Painted X Walk1?	No	N/A	Painte	ed X Walk2?	No
	X Walk 1 Direction	To SW		X Wa	lk 2 Direction	To SE
N/A	X Walk 1 Width (in)	N/A	N/A	X Wa	lk 2 Width (in)	N/A
	X Walk 1 Slope (%)	1.1		X Wa	lk 2 Slope (%)	2.4
	X Walk 1 X Slope (%)	2.0		X Wa	lk 2 X Slope (%)	0.2

N/A	Ramp inside XWalk1?	N/A	N/A	Ramp	inside XWalk2?	N/A
	Road Slope (%)	2.8	N/A	Clear	Space?	N/A
	Road X Slope (%)	0.1	N/A	Clear	Space to XWalk (in)	N/A
N/A	Any Obstructions?	N/A	N/A	Storm	Grate/Utility Hazard?	N/A
	Obstruction Type		l	Storm	Grate/Utility Type	
		N/A				N/A
			Yes	Surfa	ce Condition? (G/P)	Good

Street 1 Name Stop Condition-Street 2 Street 2 Name Stop Condition-Street 1 **Remove & Replace Curb Ramp With Two New Directional Ramps or** Equivalent.

Total Cost: 3200.00
