# Access Compliance Report

## Public Rights-of-Way

### (Curb Ramps)

Intersection ID: 9328	Main Street: PLAZA_LN	Cross Street: THE_PLAZA	Location:	N
ADA ID: CA1741B4E2CB	Ramp Type: BlendTrans1	Initial Pass/Fail: Fail	Overall Compliance: No	Severity Score: 10

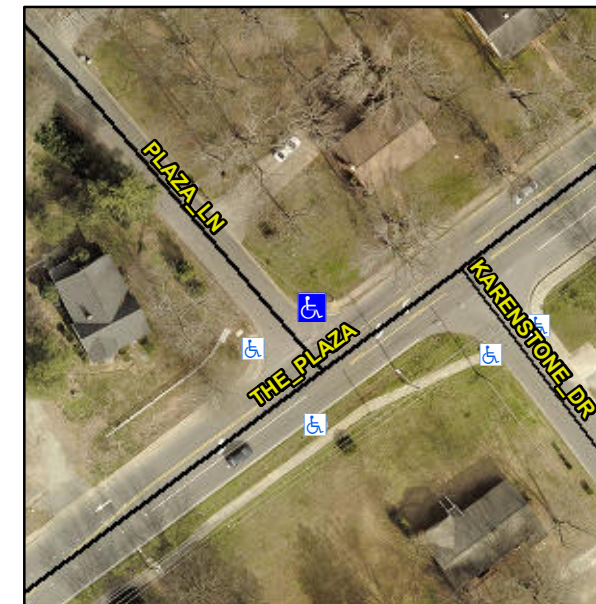
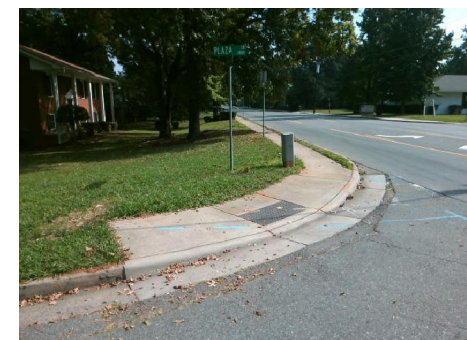
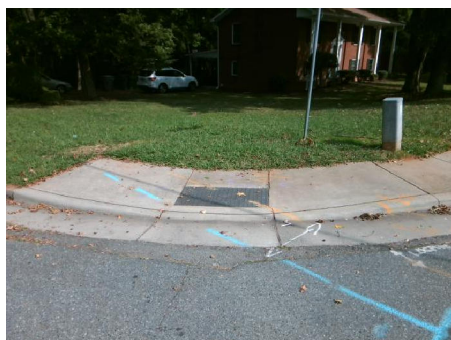
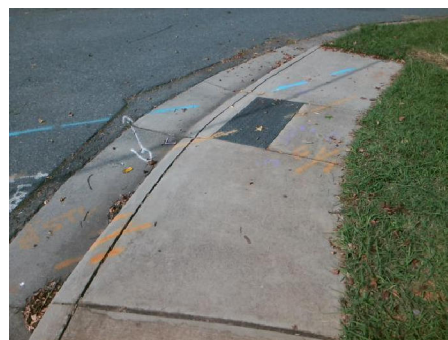
**NO LT SW**

**Not Found, R304.5.1, R304.5.3**

Compliance	Description	Data	Compliance	Description	Data
N/A	Ramp Length (in)	61.0	Yes	BlendTrans Slope (%)	3.8
No	Ramp Width (in)	47.5	No	BlendTrans XSlope (%)	2.6
N/A	Flare Type LT	N/A	N/A	Flare Type RT	N/A
N/A	Flare Slope LT (%)	N/A	N/A	Flare Slope RT (%)	N/A
N/A	Flare Traversable LT?	N/A	N/A	Flare Traversable RT?	N/A
N/A	Landing Length (in)	N/A	N/A	DWS Provided?	N/A
N/A	Landing Width (in)	N/A	N/A	DWS Contrast?	N/A
N/A	Landing Slope (%)	N/A	N/A	DWS Length (in)	N/A
N/A	Landing X Slope (%)	N/A	N/A	DWS Full Width?	N/A
N/A	Landing Curb? (Y/N)	N/A	N/A	DWS Offset (in)	N/A
N/A	Shared Landing?	N/A			
N/A	Gutter Ponding?	N/A	N/A	Gutter Slope (%)	N/A
N/A	Gutter Lip Ht (in)	N/A	N/A	Gutter X Slope (%)	N/A
N/A	Painted X Walk1?	No	N/A	Painted X Walk2?	N/A
	X Walk 1 Direction	To E		X Walk 2 Direction	N/A
	X Walk 1 Width (in)	N/A		X Walk 2 Width (in)	N/A
	X Walk 1 Slope (%)	2.2		X Walk 2 Slope (%)	N/A
	X Walk 1 X Slope (%)	1.6		X Walk 2 X Slope (%)	N/A

N/A	Ramp inside XWalk1?	N/A	N/A	Ramp inside XWalk2?	N/A
	Road Slope (%)	1.6		Clear Space?	N/A
	Road X Slope (%)	2.2	N/A	Clear Space to XWalk (in)	N/A
N/A	Any Obstructions?	N/A	N/A	Storm Grate/Utility Hazard?	N/A
	Obstruction Type			Storm Grate/Utility Type	
		N/A			N/A
			Yes	Surface Condition? (G/P)	Good
			No	Curb Slope (%)	29.4

**Remove & Replace Curb Ramp With Two New Directional Ramps or Equivalent.**
