# Access Compliance Report

## Public Rights-of-Way

### (Curb Ramps)

Intersection ID: 9373	Main Street: EUREKA_ST	Cross Street: GENESIS_PARK_PL	Location: SE
ADA ID: CA1C3289D790	Ramp Type: PerpDiag	Initial Pass/Fail: Fail	Overall Compliance: No
Severity Score: 33.75			
Codes/Mitigation Info/Possible Solution		Field Measurements/Component Compliance

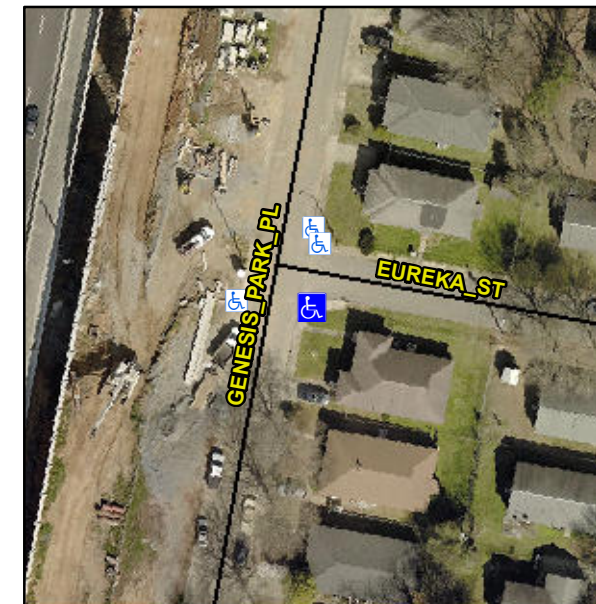
Compliance	Description	Data	Compliance	Description	Data
N/A	Ramp Length (in)	67.0	No	Ramp Slope (%)	14.9
No	Ramp Width (in)	43.0	Yes	Ramp XSlope (%)	0.6
N/A	Flare Type LT	N/A	N/A	Flare Type RT	N/A
N/A	Flare Slope LT (%)	N/A	N/A	Flare Slope RT (%)	N/A
N/A	Flare Traversable LT?	N/A	N/A	Flare Traversable RT?	N/A
N/A	Landing Length (in)	N/A	N/A	DWS Provided?	N/A
N/A	Landing Width (in)	N/A	N/A	DWS Contrast?	N/A
N/A	Landing Slope (%)	N/A	N/A	DWS Length (in)	N/A
N/A	Landing X Slope (%)	N/A	N/A	DWS Full Width?	N/A
N/A	Landing Curb? (Y/N)	N/A	N/A	DWS Offset (in)	N/A
N/A	Shared Landing?	N/A			
N/A	Gutter Ponding?	N/A	N/A	Gutter Slope (%)	N/A
N/A	Gutter Lip Ht (in)	0.5	N/A	Gutter X Slope (%)	N/A
N/A	Painted X Walk1?	No	N/A	Painted X Walk2?	No
	X Walk 1 Direction	To N		X Walk 2 Direction	To NW
N/A	X Walk 1 Width (in)	N/A	N/A	X Walk 2 Width (in)	N/A
	X Walk 1 Slope (%)	3.5		X Walk 2 Slope (%)	1.0
	X Walk 1 X Slope (%)	2.6		X Walk 2 X Slope (%)	2.8

N/A	Ramp inside XWalk1?	N/A	N/A	Ramp inside XWalk2?	N/A
	Road Slope (%)	5.1	N/A	Clear Space?	N/A
	Road X Slope (%)	3.0	N/A	Clear Space to XWalk (in)	N/A
N/A	Any Obstructions?	N/A	N/A	Storm Grate/Utility Hazard?	N/A
	Obstruction Type			Storm Grate/Utility Type	
		N/A			N/A
			Yes	Surface Condition? (G/P)	Good

**Remove & Replace Curb Ramp With Two New Directional Ramps or Equivalent.**

**R304.5.1, R304.2.2**
