# Access Compliance Report

## Public Rights-of-Way

### (Curb Ramps)

Intersection ID: 28642	Main Street: PADSTOW_CT	Cross Street: STEWARTS_CROSSING_DR	Location: SE
ADA ID: CA2AA54527F4	Ramp Type: BlendTrans1	Initial Pass/Fail: Fail	Overall Compliance: No
Codes/Mitigation Info/Possible Solution		Field Measurements/Component Compliance	
Severity Score: 10

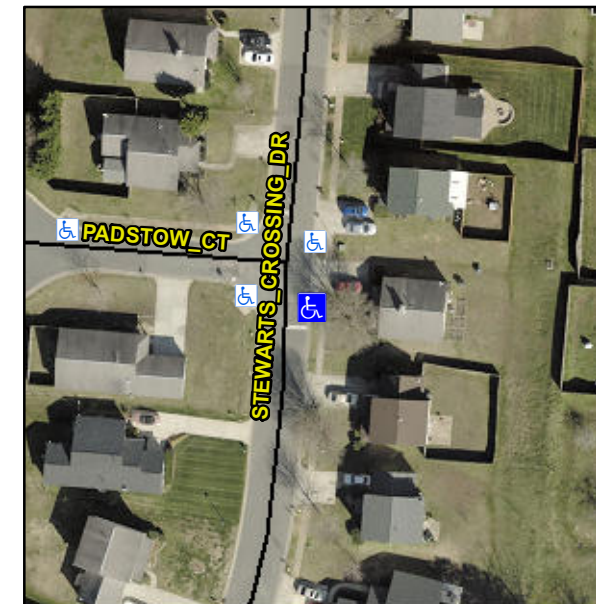
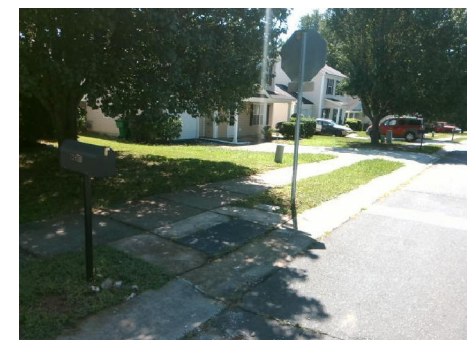
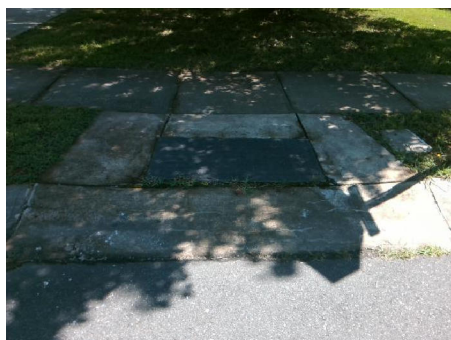
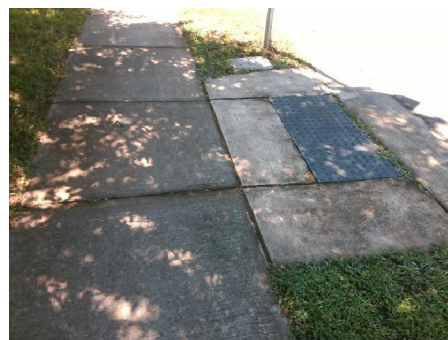
**CURB GAP 3.0**

**R304.5.1**

Compliance	Description	Data	Compliance	Description	Data
N/A	Ramp Length (in)	47.5	Yes	BlendTrans Slope (%)	1.5
No	Ramp Width (in)	45.5	Yes	BlendTrans XSlope (%)	2.3
N/A	Flare Type LT	N/A	N/A	Flare Type RT	N/A
N/A	Flare Slope LT (%)	N/A	N/A	Flare Slope RT (%)	N/A
N/A	Flare Traversable LT?	N/A	N/A	Flare Traversable RT?	N/A
N/A	Landing Length (in)	N/A	N/A	DWS Provided?	N/A
N/A	Landing Width (in)	N/A	N/A	DWS Contrast?	N/A
N/A	Landing Slope (%)	N/A	N/A	DWS Length (in)	N/A
N/A	Landing X Slope (%)	N/A	N/A	DWS Full Width?	N/A
N/A	Landing Curb? (Y/N)	N/A	N/A	DWS Offset (in)	N/A
N/A	Shared Landing?	N/A			
N/A	Gutter Ponding?	N/A	N/A	Gutter Slope (%)	N/A
N/A	Gutter Lip Ht (in)	N/A	N/A	Gutter X Slope (%)	N/A
N/A	Painted X Walk1?	No	N/A	Painted X Walk2?	N/A
	X Walk 1 Direction	To W		X Walk 2 Direction	N/A
	X Walk 1 Width (in)	N/A		X Walk 2 Width (in)	N/A
	X Walk 1 Slope (%)	3.1		X Walk 2 Slope (%)	N/A
	X Walk 1 X Slope (%)	2.6		X Walk 2 X Slope (%)	N/A

N/A	Ramp inside XWalk1?	N/A	N/A	Ramp inside XWalk2?	N/A
	Road Slope (%)	2.6		Clear Space?	N/A
	Road X Slope (%)	3.1	N/A	Clear Space to XWalk (in)	N/A
N/A	Any Obstructions?	N/A	N/A	Storm Grate/Utility Hazard?	N/A
	Obstruction Type			Storm Grate/Utility Type	
		N/A			N/A
			Yes	Surface Condition? (G/P)	Good
			N/A	Curb Slope (%)	4.1

**Remove & Replace Curb Ramp With Two New Directional Ramps or Equivalent.**
