# Access Compliance Report

## Public Rights-of-Way

### (Curb Ramps)

Intersection ID: 14648	Main Street: EAST_BV	Cross Street: LENNOX_AV	Location: E
ADA ID: CA2B8EBFA783	Ramp Type: Directional1	Initial Pass/Fail: Pass	Overall Compliance: No
Severity Score: 15.25			
Codes/Mitigation Info/Possible Solution		Field Measurements/Component Compliance

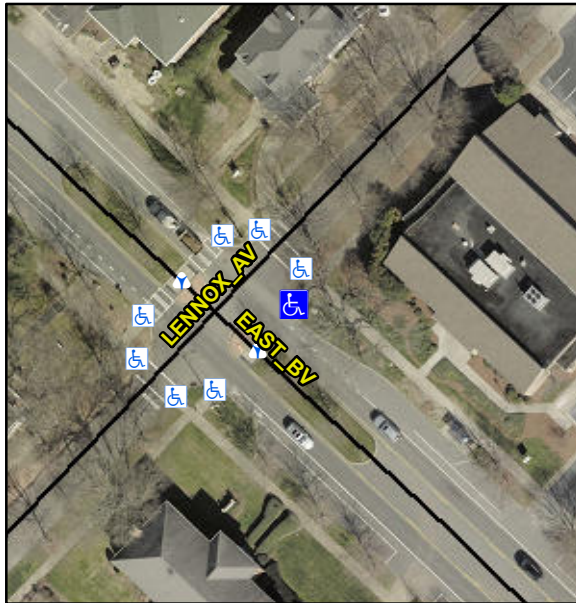
**LNDG SLOPE NEGATIVE, GTR GAP  
18.0"**

**R304.5.3, R304.2.2-Perp, R304.3.2-  
Para, R302.7.2**

Compliance	Description	Data	Compliance	Description	Data
N/A	Ramp Length (in)	69.0	Yes	Grade Break?	Yes
Yes	Ramp Width (in)	72.0	Yes	Grade Break Slope (%)	2.5
Yes	Ramp Slope (%)	3.9	Yes	Grade Break XSlope (%)	1.7
No	Ramp XSlope (%)	2.2			
Yes	Flare Type LT	N/A	Yes	Flare Type RT	N/A
N/A	Flare Slope LT (%)	N/A	N/A	Flare Slope RT (%)	N/A
N/A	Flare Traversable LT?	No	N/A	Flare Traversable RT?	No
Yes	Landing Length (in)	54.0	Yes	DWS Provided?	Yes
Yes	Landing Width (in)	72.0	Yes	DWS Contrast?	Yes
No	Landing Slope (%)	7.8	Yes	DWS Length (in)	25.0
Yes	Landing X Slope (%)	0.2	Yes	DWS Full Width?	Yes
N/A	Landing Curb? (Y/N)	No	Yes	DWS Offset LT (in)	0.0
N/A	Shared Landing?	No	Yes	DWS Offset RT (in)	26.0
Yes	Gutter Ponding?	No	Yes	Gutter Slope (%)	4.0
No	Gutter Lip Ht (in)	3.0	Yes	Gutter X Slope (%)	1.1
N/A	Painted X Walk1?	No		Road Slope (%)	3.7
	X Walk 1 Direction	To SW		Road X Slope (%)	1.0
	X Walk 1 Width (in)	N/A		Clear Space?	Yes

X Walk 1 Slope (%)	3.7	N/A	Clear Space to XWalk (in)	N/A
	X Walk 1 X Slope (%)	1.0	Yes	Storm Grate/Utility Hazard?	No
N/A	Ramp inside XWalk1?	N/A		Storm Grate/Utility Type	
Yes	Any Obstructions?	No			N/A
	Obstruction Type		Yes	Surface Condition? (G/P)	Good
			N/A	Curb Slope (%)	3.4

Possible Solutions:

**Remove & Replace Entire Ramp.  
Grind Gutter Lip.**
