Access Compliance Report

Public Rights-of-Way

(Curb Ramps)

| Intersection ID: 43114 | Main Street: HAMORTON_PL | Cross Street: THE_PLAZA | Location: SW |

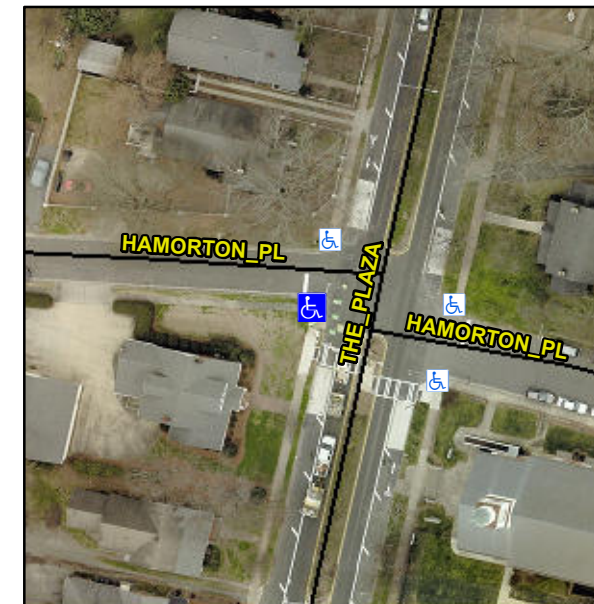
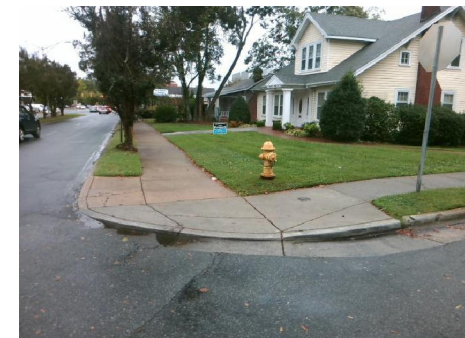
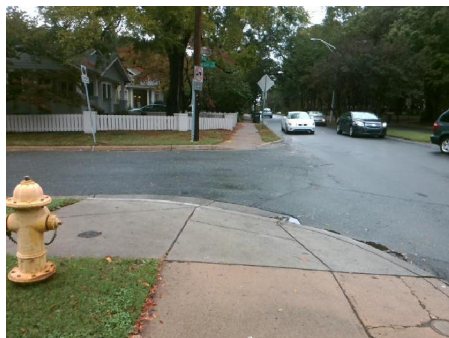
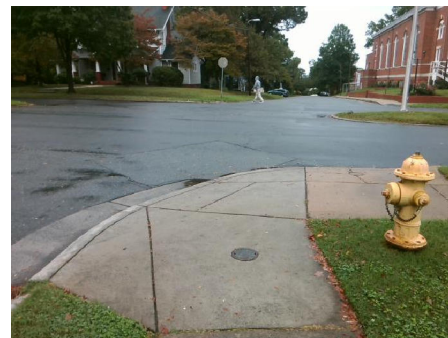
| ADA ID: CA42691BFB0A | Ramp Type: BlendTrans1 | Initial Pass/Fail: Fail | Overall Compliance: No |
| | | Severity Score: 8.75 | |

R304.5.1

| Compliance | Description | Data | Compliance | Description | Data |
|---|---|---|---|---|---|
| No | Ramp Width (in) | 47.0 | Yes | BlendTrans XSlope (%) | 0.2 |

Remove & Replace Curb Ramp With Two New Directional Ramps or Equivalent.

Total Cost: \$ 3200.00
