# Access Compliance Report

## Public Rights-of-Way

### (Curb Ramps)

Intersection ID: 51539	Main Street: TRIEG_DR	Cross Street: GLENBURN_LN	Location: S
ADA ID: CA4D4C1693D4	Ramp Type: Perp	Initial Pass/Fail: Fail	Overall Compliance: No
Severity Score: 8.75			
Codes/Mitigation Info/Possible Solution		Field Measurements/Component Compliance

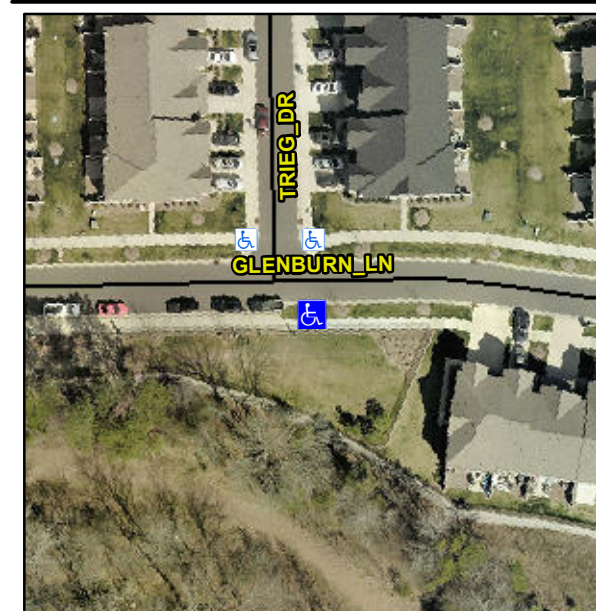
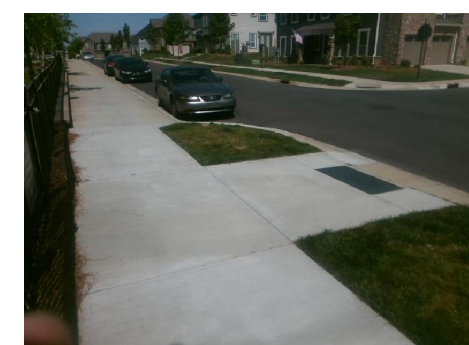
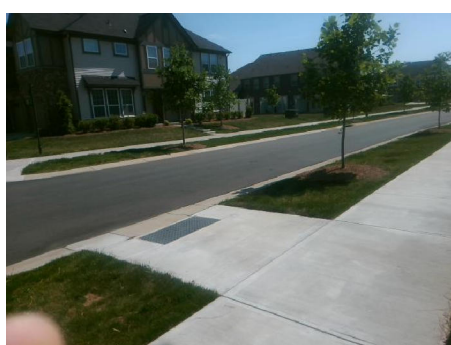
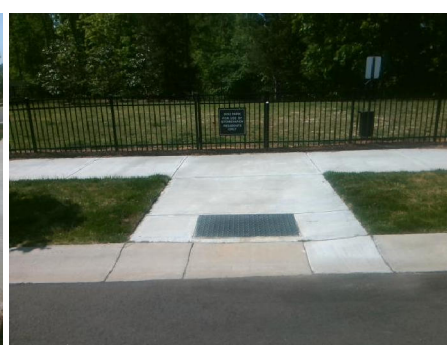
**Not Found, R304.5.1**

Compliance	Description	Data	Compliance	Description	Data
N/A	Ramp Length (in)	91.0	Yes	Ramp Slope (%)	5.6
No	Ramp Width (in)	46.5	Yes	Ramp XSlope (%)	0.7
N/A	Flare Type LT	N/A	N/A	Flare Type RT	N/A
N/A	Flare Slope LT (%)	N/A	N/A	Flare Slope RT (%)	N/A
N/A	Flare Traversable LT?	N/A	N/A	Flare Traversable RT?	N/A
N/A	Landing Length (in)	N/A	N/A	DWS Provided?	N/A
N/A	Landing Width (in)	N/A	N/A	DWS Contrast?	N/A
N/A	Landing Slope (%)	N/A	N/A	DWS Length (in)	N/A
N/A	Landing X Slope (%)	N/A	N/A	DWS Full Width?	N/A
N/A	Landing Curb? (Y/N)	N/A	N/A	DWS Offset (in)	N/A
N/A	Shared Landing?	N/A			
N/A	Gutter Ponding?	N/A	N/A	Gutter Slope (%)	N/A
N/A	Gutter Lip Ht (in)	N/A	N/A	Gutter X Slope (%)	N/A
N/A	Painted X Walk1?	No	N/A	Painted X Walk2?	N/A
	X Walk 1 Direction	To N		X Walk 2 Direction	N/A
N/A	X Walk 1 Width (in)	N/A	N/A	X Walk 2 Width (in)	N/A
	X Walk 1 Slope (%)	2.5		X Walk 2 Slope (%)	N/A
	X Walk 1 X Slope (%)	1.2		X Walk 2 X Slope (%)	N/A

N/A	Ramp inside XWalk1?	N/A	N/A	Ramp inside XWalk2?	N/A
	Road Slope (%)	N/A	N/A	Clear Space?	N/A
	Road X Slope (%)	N/A	N/A	Clear Space to XWalk (in)	N/A
N/A	Any Obstructions?	N/A	N/A	Storm Grate/Utility Hazard?	N/A
	Obstruction Type			Storm Grate/Utility Type	
		N/A			N/A
			Yes	Surface Condition? (G/P)	Good

**Remove & Replace Entire Ramp.**
