Access Compliance Report

Public Rights-of-Way

(Curb Ramps)

Intersection ID: 20410	Main Street: CARMEL_RD	Cross Street: FAIRVIEW_RD	Location: SW
ADA ID: CA6AF528869B	Ramp Type: PerpDiag	Initial Pass/Fail: Fail	Overall Compliance: No
		Severity Score: 37.5

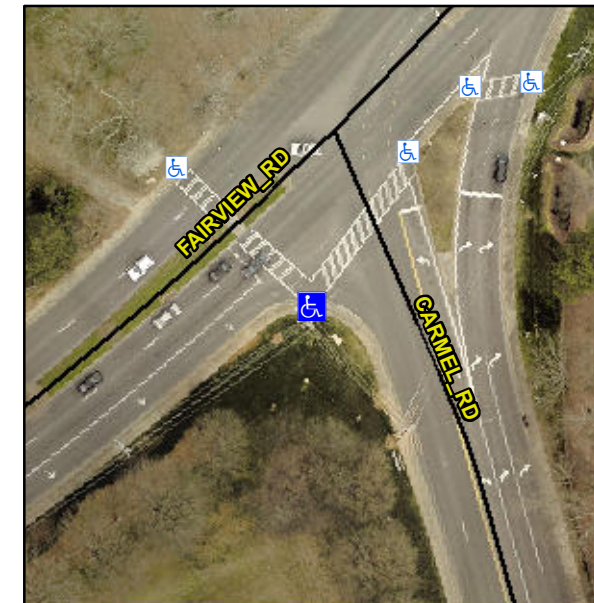
Not Found, R304.2.2, R304.5.3

Compliance	Description	Data	Compliance	Description	Data
N/A	Ramp Length (in)	60.0	No	Ramp Slope (%)	8.7
Yes	Ramp Width (in)	120.0	No	Ramp XSlope (%)	9.2
N/A	Flare Type LT	N/A	N/A	Flare Type RT	N/A
N/A	Flare Slope LT (%)	N/A	N/A	Flare Slope RT (%)	N/A
N/A	Flare Traversable LT?	N/A	N/A	Flare Traversable RT?	N/A
N/A	Landing Length (in)	N/A	N/A	DWS Provided?	N/A
N/A	Landing Width (in)	N/A	N/A	DWS Contrast?	N/A
N/A	Landing Slope (%)	N/A	N/A	DWS Length (in)	N/A
N/A	Landing X Slope (%)	N/A	N/A	DWS Full Width?	N/A
N/A	Landing Curb? (Y/N)	N/A	N/A	DWS Offset (in)	N/A
N/A	Shared Landing?	N/A			
N/A	Gutter Ponding?	N/A	N/A	Gutter Slope (%)	N/A
N/A	Gutter Lip Ht (in)	N/A	N/A	Gutter X Slope (%)	N/A
N/A	Painted X Walk1?	Yes	N/A	Painted X Walk2?	Yes
	X Walk 1 Direction	To NE		X Walk 2 Direction	To NW
N/A	X Walk 1 Width (in)	127.0	N/A	X Walk 2 Width (in)	120.0
	X Walk 1 Slope (%)	0.3		X Walk 2 Slope (%)	7.5
	X Walk 1 X Slope (%)	6.3		X Walk 2 X Slope (%)	1.7

N/A	Ramp inside XWalk1?	Yes	N/A	Ramp inside XWalk2?	Yes
	Road Slope (%)	5.6	N/A	Clear Space?	N/A
	Road X Slope (%)	3.2	N/A	Clear Space to XWalk (in)	N/A
N/A	Any Obstructions?	N/A	N/A	Storm Grate/Utility Hazard?	N/A
	Obstruction Type			Storm Grate/Utility Type	
		N/A			N/A
		Yes		Surface Condition? (G/P)	Good

Remove & Replace Curb Ramp With Two New Directional Ramps or Equivalent.

Total Cost: \$ 3200.00
