Access Compliance Report

Public Rights-of-Way

(Curb Ramps)

| Intersection ID: 8375 | Main Street: HOOD_RD | Cross Street: STEEPLETON_WY | Location: SE |

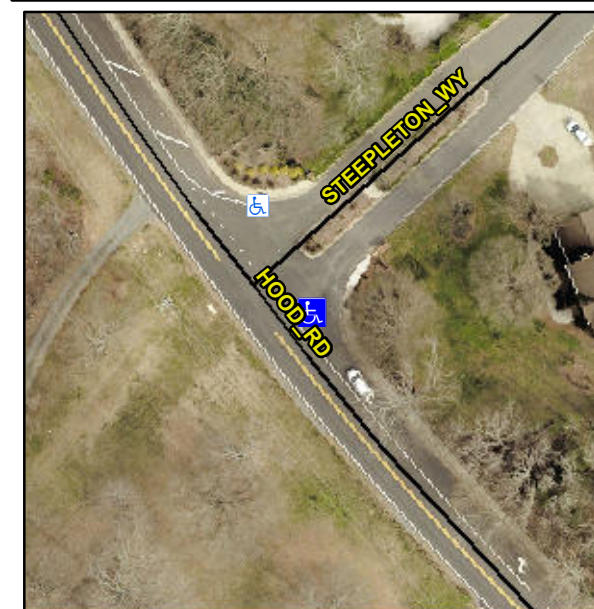
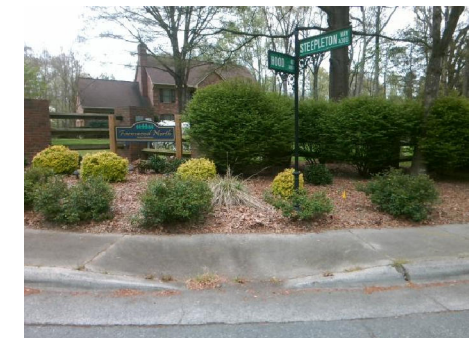
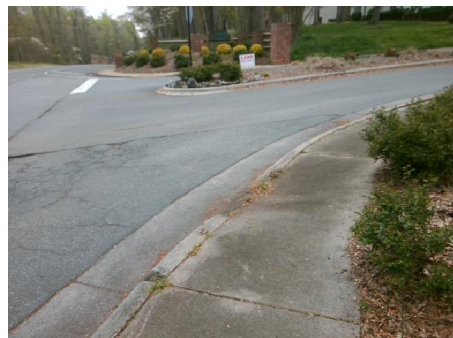
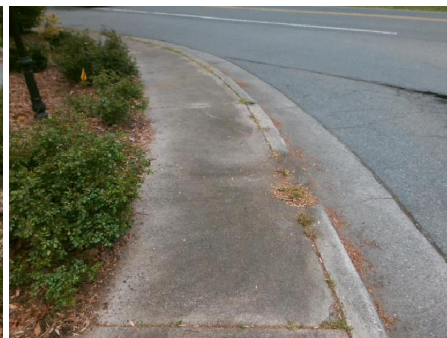
| ADA ID: CA7AFE49FC17 | Ramp Type: Perp | Initial Pass/Fail: Fail | Overall Compliance: No |

Not Found, R304.5.1, R304.2.2, R304.5.3

| Compliance | Description | Data | Compliance | Description | Data |
|---|---|---|---|---|---|
| N/A | Ramp Length (in) | 48.0 | No | Ramp Slope (%) | 15.3 |
| No | Ramp Width (in) | 36.0 | No | Ramp XSlope (%) | 4.0 |

Remove & Replace Entire Ramp.
