Access Compliance Report

Public Rights-of-Way

(Curb Ramps)

Intersection ID: 51073	Main Street: RISBURG_LN	Cross Street: KEMPSFORD_DR	Location: E
ADA ID: CA82FFD2F83A	Ramp Type: Perp	Initial Pass/Fail: Fail	Overall Compliance: No
Codes/Mitigation Info/Possible Solution		Field Measurements/Component Compliance	
Severity Score: 13.75

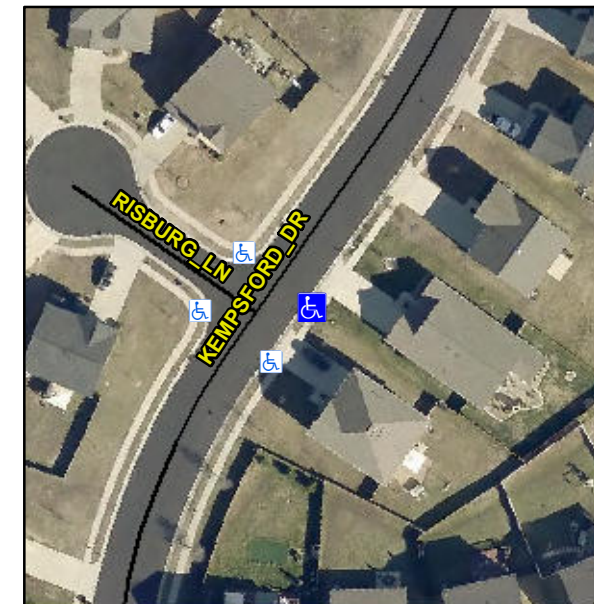
Not Found, R304.2.2, R304.5.3

Compliance	Description	Data	Compliance	Description	Data
N/A	Ramp Length (in)	48.0	No	Ramp Slope (%)	8.5
Yes	Ramp Width (in)	48.0	No	Ramp XSlope (%)	2.1
N/A	Flare Type LT	N/A	N/A	Flare Type RT	N/A
N/A	Flare Slope LT (%)	N/A	N/A	Flare Slope RT (%)	N/A
N/A	Flare Traversable LT?	N/A	N/A	Flare Traversable RT?	N/A
N/A	Landing Length (in)	N/A	N/A	DWS Provided?	N/A
N/A	Landing Width (in)	N/A	N/A	DWS Contrast?	N/A
N/A	Landing Slope (%)	N/A	N/A	DWS Length (in)	N/A
N/A	Landing X Slope (%)	N/A	N/A	DWS Full Width?	N/A
N/A	Landing Curb? (Y/N)	N/A	N/A	DWS Offset (in)	N/A
N/A	Shared Landing?	N/A			
N/A	Gutter Ponding?	N/A	N/A	Gutter Slope (%)	N/A
N/A	Gutter Lip Ht (in)	0.5	N/A	Gutter X Slope (%)	N/A
N/A	Painted X Walk1?	No	N/A	Painted X Walk2?	N/A
	X Walk 1 Direction	To NW		X Walk 2 Direction	N/A
N/A	X Walk 1 Width (in)	N/A	N/A	X Walk 2 Width (in)	N/A
	X Walk 1 Slope (%)	4.2		X Walk 2 Slope (%)	N/A
	X Walk 1 X Slope (%)	1.9		X Walk 2 X Slope (%)	N/A

N/A	Ramp inside XWalk1?	N/A	N/A	Ramp inside XWalk2?	N/A
	Road Slope (%)	N/A	N/A	Clear Space?	N/A
	Road X Slope (%)	N/A	N/A	Clear Space to XWalk (in)	N/A
N/A	Any Obstructions?	N/A	N/A	Storm Grate/Utility Hazard?	N/A
	Obstruction Type			Storm Grate/Utility Type	
		N/A			N/A
			Yes	Surface Condition? (G/P)	Good

Possible Solutions:

Remove & Replace Entire Ramp.

Total Cost: \$ 1850.00
