# Access Compliance Report

## Public Rights-of-Way

| Intersection ID: 48450 | Main Street: DUSTY_SADDLE_RD | Cross Street: RED_RUST_LN | Location: SE |
| ADA ID: CA879B59EDBB | Ramp Type: BlendTrans2 | Initial Pass/Fail: Fail | Overall Compliance: No |

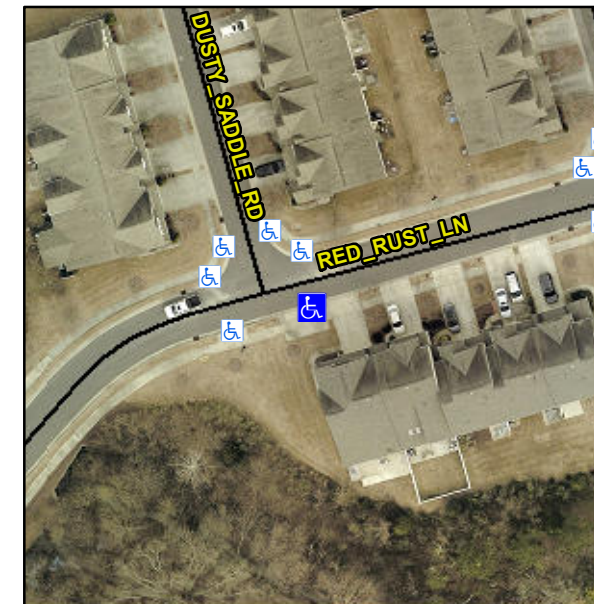
| | | Severity Score: 10 | |

**Not Found, R304.5.1, R304.5.3**

| Compliance | Description | Data | Compliance | Description | Data |
|---|---|---|---|---|---|
| No | Ramp Width (in) | 47.0 | No | BlendTrans XSlope (%) | 2.4 |
| | | | No | Curb Slope (%) | 13.0 |

**Remove & Replace Curb Ramp With Two New Directional Ramps or Equivalent.**

Total Cost: \$ 3200.00
