# Access Compliance Report

## Public Rights-of-Way

### (Curb Ramps)

Intersection ID: 15174	Main Street: DILWORTH RD WEST	Cross Street: IDEAL_WY	Location: SW
ADA ID: CA8C66C7C685	Ramp Type: Perp	Initial Pass/Fail: Fail	Overall Compliance: No
			Severity Score: 1.25

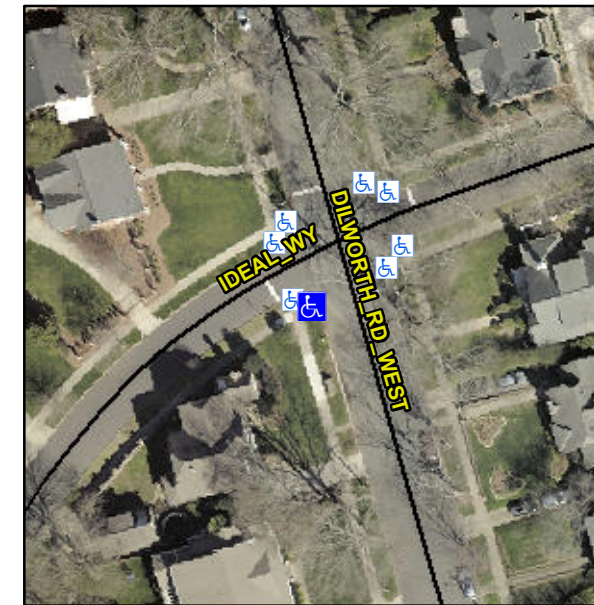
**Not Found, R304.5.3**

Compliance	Description	Data	Compliance	Description	Data
N/A	Ramp Length (in)	24.0	Yes	Ramp Slope (%)	5.2
Yes	Ramp Width (in)	60.0	No	Ramp XSlope (%)	2.6
N/A	Flare Type LT	N/A	N/A	Flare Type RT	N/A
N/A	Flare Slope LT (%)	N/A	N/A	Flare Slope RT (%)	N/A
N/A	Flare Traversable LT?	N/A	N/A	Flare Traversable RT?	N/A
N/A	Landing Length (in)	N/A	N/A	DWS Provided?	N/A
N/A	Landing Width (in)	N/A	N/A	DWS Contrast?	N/A
N/A	Landing Slope (%)	N/A	N/A	DWS Length (in)	N/A
N/A	Landing X Slope (%)	N/A	N/A	DWS Full Width?	N/A
N/A	Landing Curb? (Y/N)	N/A	N/A	DWS Offset (in)	N/A
N/A	Shared Landing?	N/A			
N/A	Gutter Ponding?	N/A	N/A	Gutter Slope (%)	N/A
N/A	Gutter Lip Ht (in)	N/A	N/A	Gutter X Slope (%)	N/A
N/A	Painted X Walk1?	No	N/A	Painted X Walk2?	N/A
	X Walk 1 Direction	To NE		X Walk 2 Direction	N/A
N/A	X Walk 1 Width (in)	N/A	N/A	X Walk 2 Width (in)	N/A
	X Walk 1 Slope (%)	6.4		X Walk 2 Slope (%)	N/A
	X Walk 1 X Slope (%)	0.5		X Walk 2 X Slope (%)	N/A

N/A	Ramp inside XWalk1?	N/A	N/A	Ramp inside XWalk2?	N/A
	Road Slope (%)	N/A	N/A	Clear Space?	N/A
	Road X Slope (%)	N/A	N/A	Clear Space to XWalk (in)	N/A
N/A	Any Obstructions?	N/A	N/A	Storm Grate/Utility Hazard?	N/A
	Obstruction Type			Storm Grate/Utility Type	
		N/A			N/A
			Yes	Surface Condition? (G/P)	Good

Possible Solutions:

**Remove & Replace Entire Ramp.**

Total Cost: \$ 1850.00
