Access Compliance Report

Public Rights-of-Way

(Curb Ramps)

Intersection ID: 21797	Main Street: GALLERIA_BV	Cross Street: MONROE_RD	Location: SW
ADA ID: CA8F751D9078	Ramp Type: Perp	Initial Pass/Fail: Fail	Overall Compliance: No
		Severity Score: 12.5

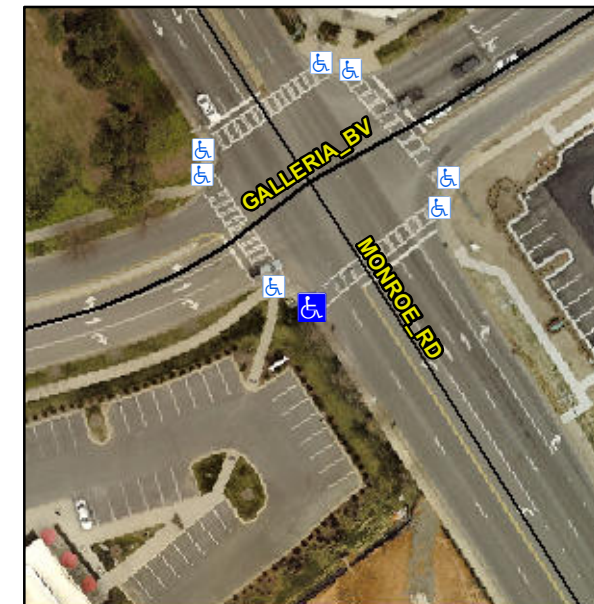
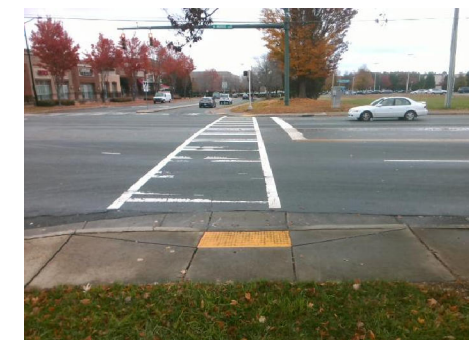
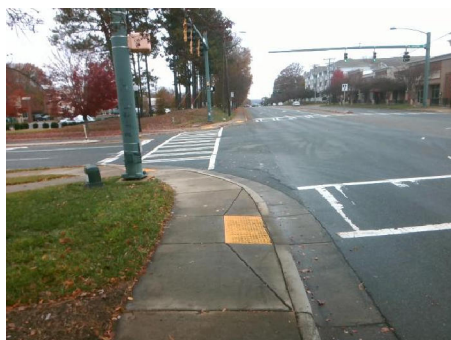
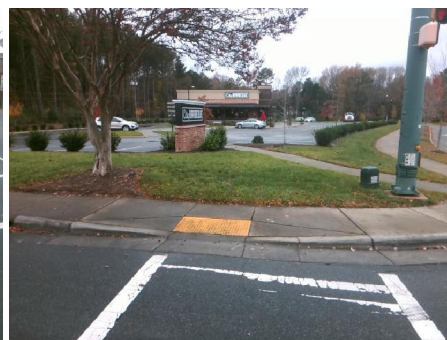
Not Found, R304.2.2

Compliance	Description	Data	Compliance	Description	Data
N/A	Ramp Length (in)	24.5	No	Ramp Slope (%)	8.6
Yes	Ramp Width (in)	48.0	Yes	Ramp XSlope (%)	1.6
N/A	Flare Type LT	N/A	N/A	Flare Type RT	N/A
N/A	Flare Slope LT (%)	N/A	N/A	Flare Slope RT (%)	N/A
N/A	Flare Traversable LT?	N/A	N/A	Flare Traversable RT?	N/A
N/A	Landing Length (in)	N/A	N/A	DWS Provided?	N/A
N/A	Landing Width (in)	N/A	N/A	DWS Contrast?	N/A
N/A	Landing Slope (%)	N/A	N/A	DWS Length (in)	N/A
N/A	Landing X Slope (%)	N/A	N/A	DWS Full Width?	N/A
N/A	Landing Curb? (Y/N)	N/A	N/A	DWS Offset (in)	N/A
N/A	Shared Landing?	N/A			
N/A	Gutter Ponding?	N/A	N/A	Gutter Slope (%)	N/A
N/A	Gutter Lip Ht (in)	N/A	N/A	Gutter X Slope (%)	N/A
N/A	Painted X Walk1?	Yes	N/A	Painted X Walk2?	N/A
	X Walk 1 Direction	To NE		X Walk 2 Direction	N/A
N/A	X Walk 1 Width (in)	104.0	N/A	X Walk 2 Width (in)	N/A
	X Walk 1 Slope (%)	3.1		X Walk 2 Slope (%)	N/A
	X Walk 1 X Slope (%)	1.8		X Walk 2 X Slope (%)	N/A

Remove & Replace Entire Ramp.
