Access Compliance Report

Public Rights-of-Way

(Curb Ramps)

Intersection ID: 44015	Main Street: ATWATER_LN	Cross Street: MANTARIO_DR	Location: SE
ADA ID: CAA1C8C48988	Ramp Type: BlendTrans1	Initial Pass/Fail: Fail	Overall Compliance: No
		Severity Score: 30

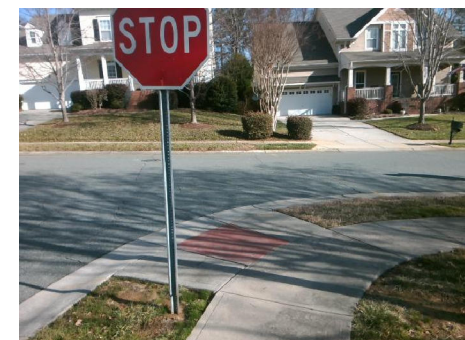
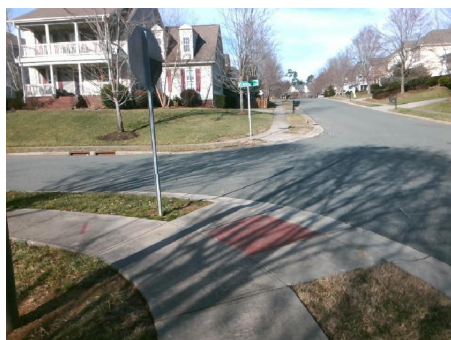
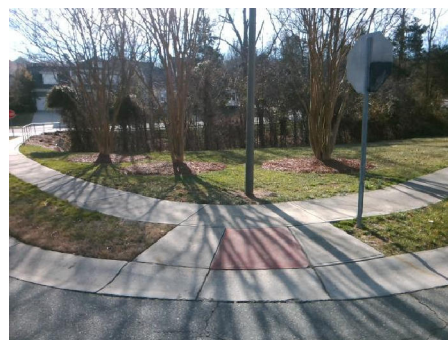
Compliance	Description	Data	Compliance	Description	Data
N/A	Ramp Length (in)	48.0	Yes	BlendTrans Slope (%)	1.8
No	Ramp Width (in)	35.0	No	BlendTrans XSlope (%)	5.3
N/A	Flare Type LT	N/A	N/A	Flare Type RT	N/A
N/A	Flare Slope LT (%)	N/A	N/A	Flare Slope RT (%)	N/A
N/A	Flare Traversable LT?	N/A	N/A	Flare Traversable RT?	N/A
N/A	Landing Length (in)	N/A	N/A	DWS Provided?	N/A
N/A	Landing Width (in)	N/A	N/A	DWS Contrast?	N/A
N/A	Landing Slope (%)	N/A	N/A	DWS Length (in)	N/A
N/A	Landing X Slope (%)	N/A	N/A	DWS Full Width?	N/A
N/A	Landing Curb? (Y/N)	N/A	N/A	DWS Offset (in)	N/A
N/A	Shared Landing?	N/A			
N/A	Gutter Ponding?	N/A	N/A	Gutter Slope (%)	N/A
N/A	Gutter Lip Ht (in)	N/A	N/A	Gutter X Slope (%)	N/A
N/A	Painted X Walk1?	No	N/A	Painted X Walk2?	No
	X Walk 1 Direction	To NE		X Walk 2 Direction	To NW
	X Walk 1 Width (in)	N/A		X Walk 2 Width (in)	N/A
	X Walk 1 Slope (%)	0.6		X Walk 2 Slope (%)	2.3
	X Walk 1 X Slope (%)	4.9		X Walk 2 X Slope (%)	2.5

N/A	Ramp inside XWalk1?	N/A	N/A	Ramp inside XWalk2?	N/A
	Road Slope (%)	2.0		Clear Space?	N/A
	Road X Slope (%)	1.4	N/A	Clear Space to XWalk (in)	N/A
N/A	Any Obstructions?	N/A	N/A	Storm Grate/Utility Hazard?	N/A
	Obstruction Type			Storm Grate/Utility Type	
		N/A			N/A
			Yes	Surface Condition? (G/P)	Good
			N/A	Curb Slope (%)	1.2

Remove & Replace Curb Ramp With Two New Directional Ramps or Equivalent.
