Access Compliance Report

Public Rights-of-Way

(Curb Ramps)

Intersection ID: 45493	Main Street: BUGGY_HORSE_RD	Cross Street: TREE_CANOPY_RD	Location: S
ADA ID: CAA216B7A1FB	Ramp Type: PerpDiag	Initial Pass/Fail: Fail	Overall Compliance: No
		Severity Score: 22.5

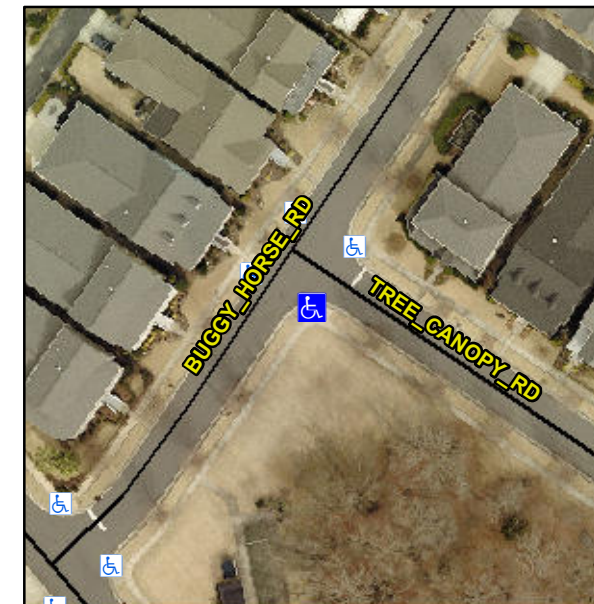
Not Found, R304.5.1, R304.2.2, R304.5.3

Compliance	Description	Data	Compliance	Description	Data
N/A	Ramp Length (in)	71.0	No	Ramp Slope (%)	10.3
No	Ramp Width (in)	38.0	No	Ramp XSlope (%)	2.3
N/A	Flare Type LT	N/A	N/A	Flare Type RT	N/A
N/A	Flare Slope LT (%)	N/A	N/A	Flare Slope RT (%)	N/A
N/A	Flare Traversable LT?	N/A	N/A	Flare Traversable RT?	N/A
N/A	Landing Length (in)	N/A	N/A	DWS Provided?	N/A
N/A	Landing Width (in)	N/A	N/A	DWS Contrast?	N/A
N/A	Landing Slope (%)	N/A	N/A	DWS Length (in)	N/A
N/A	Landing X Slope (%)	N/A	N/A	DWS Full Width?	N/A
N/A	Landing Curb? (Y/N)	N/A	N/A	DWS Offset (in)	N/A
N/A	Shared Landing?	N/A			
N/A	Gutter Ponding?	N/A	N/A	Gutter Slope (%)	N/A
N/A	Gutter Lip Ht (in)	N/A	N/A	Gutter X Slope (%)	N/A
N/A	Painted X Walk1?	No	N/A	Painted X Walk2?	No
	X Walk 1 Direction	To NE		X Walk 2 Direction	To NW
N/A	X Walk 1 Width (in)	N/A	N/A	X Walk 2 Width (in)	N/A
	X Walk 1 Slope (%)	1.6		X Walk 2 Slope (%)	2.3
	X Walk 1 X Slope (%)	1.7		X Walk 2 X Slope (%)	1.3

N/A	Ramp inside XWalk1?	N/A	N/A	Ramp inside XWalk2?	N/A
	Road Slope (%)	0.0	N/A	Clear Space?	N/A
	Road X Slope (%)	2.3	N/A	Clear Space to XWalk (in)	N/A
N/A	Any Obstructions?	N/A	N/A	Storm Grate/Utility Hazard?	N/A
	Obstruction Type			Storm Grate/Utility Type	
		N/A			N/A
			Yes	Surface Condition? (G/P)	Good

Possible Solutions:

Remove & Replace Curb Ramp With Two New Directional Ramps or Equivalent.
