# Access Compliance Report

## Public Rights-of-Way

### (Curb Ramps)

| Intersection ID: 11985 | Main Street: MCGILL_GARDEN_WY | Cross Street: N_DAVIDSON_ST | Location: SW |

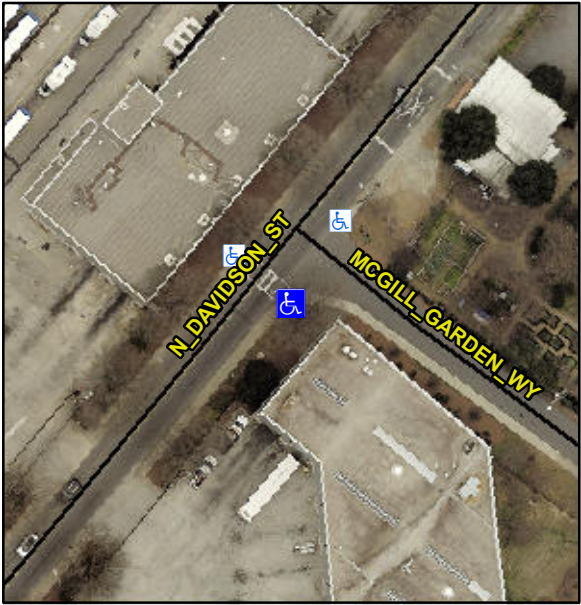
| ADA ID: CAAE5F053348 | Ramp Type: PerpDiag | Initial Pass/Fail: Fail | Overall Compliance: No |

| Codes/Mitigation Info/Possible Solution | | | Field Measurements/Component Compliance | | |
|---|---|--|---|---|---|
| | <b>Remove &amp; Replace Curb Ramp With Two New Directional Ramps or Equivalent.</b> | | <b>No</b> | Ramp Length (in) | 50.0 |
| | | | <b>No</b> | Ramp Width (in) | 43.0 |
| <p>Surveyor Notes:</p> <p><b>N/A</b></p> <p>PROW/ADA:</p> <p><b>Not Found, R304.5.1, R304.2.2</b></p> | | | <b>N/A</b> | Flare Type RT | N/A |
